Experiment title: High resolution X-ray tomography in the study of damages inside microheterogeneous materials

Experiment number
HC 538:

Beamline:
D5/ID19

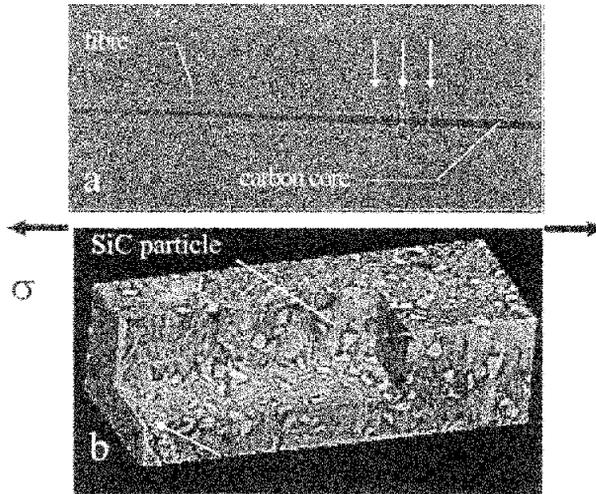
- 1) The fibre in the aluminium matrix was broken during the tensile test, as can be seen on figure 1a which represents one specific plane, parallel to the fibre. In fact, three cracks are observed; the central one seems to have been generated on a matrix porosity. No cracks in the matrix and no debondings along the matrix/fibre interface are observed within the experimental resolution.

- 2) In the particle composite, the only damage feature detected is the cracking of the matrix (fig. 1b). It is interesting to note that internal porosities do not reveal to be potential cracks initiators during monotonic tensile tests for the experimental condition investigated. Instead, cracks are all generated at the sample surface. No particle cracking or particle/matrix debonding are observed, probably because of the unloaded state of the sample. Thanks to the 3D reconstruction, the cracks interaction with SiC particles can be easily followed within the material as a function of the strain level.

Figure 1: Reconstructed images showing damages induced by tensile test inside aluminium matrix composites a) fibre reinforced, b) particle reinforced. White arrows indicate cracks. For both samples, stress was applied along the direction indicated by black arrows. On image a the carbon core ($40\ \mu\text{m}$ diameter) is clearly seen, inside the fibre ($140\ \mu\text{m}$ diameter). On image b a part of the material was removed to display the inside of the sample.
