1. Summary of MA2117 Experiment, ID15, May 2014

Numerous tests involving a range of operating and abuse conditions were performed with the ultimate aim of comparing the behaviour of different cell types and chemistries over various conditions.

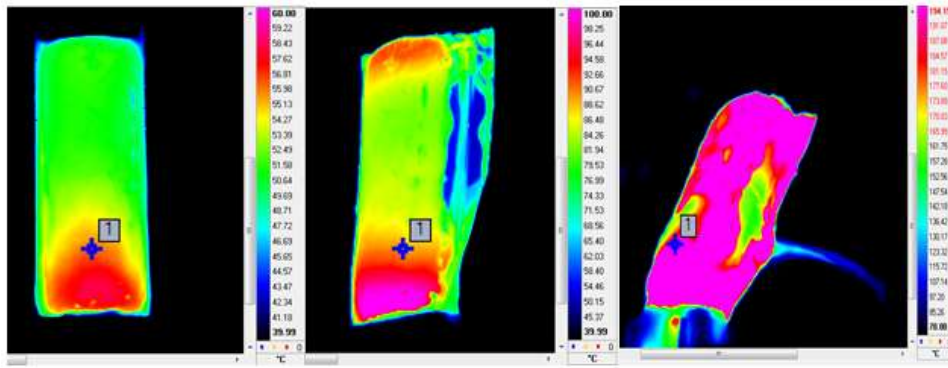
Fig. 2. Thermal image at initial stages of discharge. Thermal image during swelling and before rupture. Thermal image during thermal runaway.

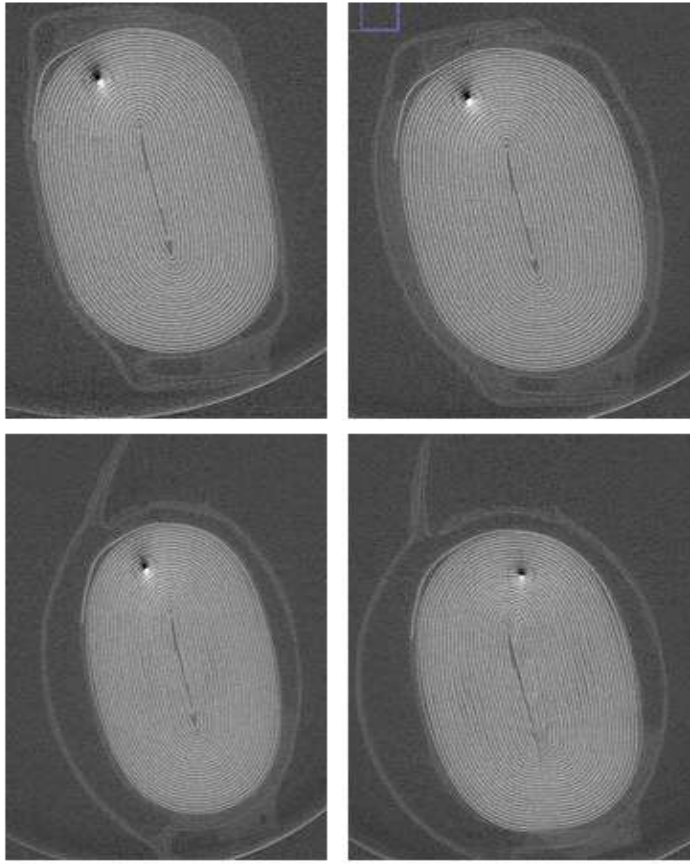
Fig. 4. Sequential tomographs taken over the first 17 s of the rapid discharge abuse test. The initial rapid swelling from internal gas generation is seen.

Rapid discharge of the LiPo cells resulted in significant heating causing the batteries to reach $>100\text{ }^{\circ}\text{C}$ before thermal runaway. The gas evolution resulting from the vaporisation of electrolyte material caused the pouch to swell and the electrodes to delaminate.

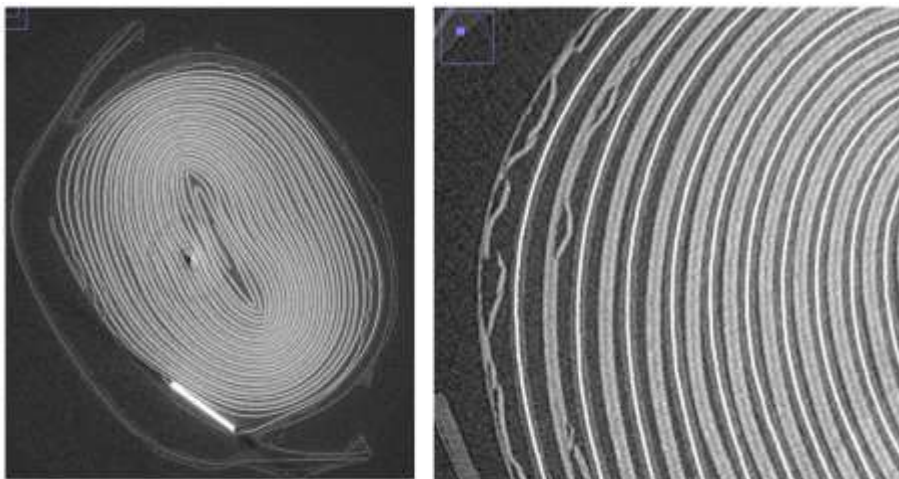
Fig. 5. Postmortem tomograph showing the remnants of the LiPo cell after a rapid discharge abuse test at 60 C (9.6 A). Postmortem tomograph showing delamination of electrode material due to gas evolution.

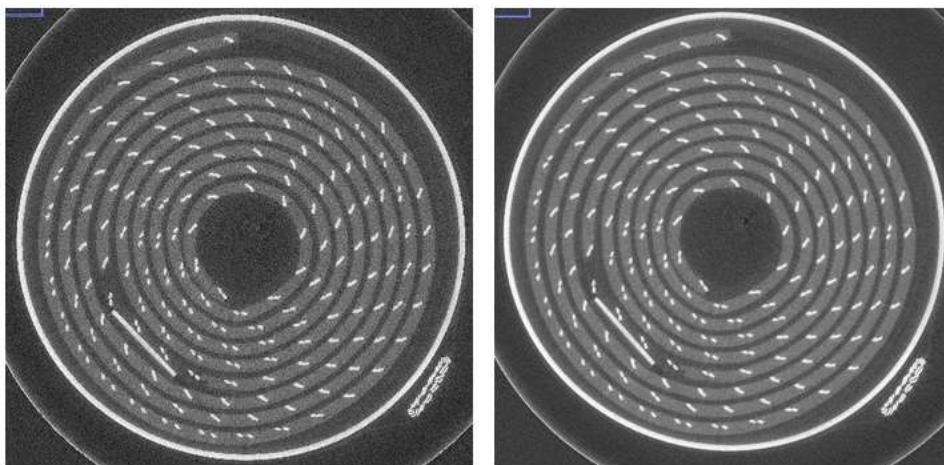
Fig. 9. Tomograph of CR2 battery at the beginning of 8 A rapid discharge. Tomograph of CR2 battery after 17 s of 8 A rapid discharge began.

Over 17 s of 8 A discharge there was no noticeable change in the electrode structure and no visible evidence of degradation. The increasing potential over the first 5 s indicates an increase in resistance potentially caused by the PTC. This would have limited the current flowing through the device. The region of the PTC in the thermal images appears to get significantly hotter than the main body of the battery which also indicates the activity of the PTC.

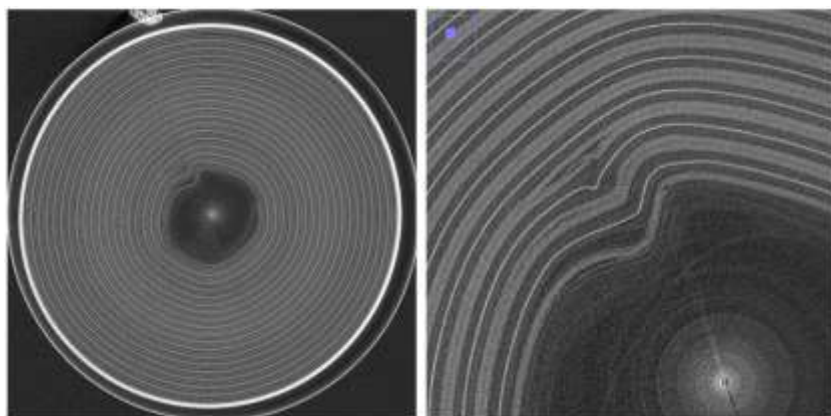
Fig. 14. Tomograph of 2.2 Ah NMC 18650 cell after overcharge at 6 A for ca. 700 s. Zoomed tomograph showing breakdown of electrode material. The formation of a gas pocket at the separator region indicated the oxidation of electrolyte material.

16 tomographies captured the progression of this degradation. Rapid heat was observed after ca. 500 s potentially caused by exothermic electrolyte degradation reactions. The lack of internal support in the 2.2 Ah NMC cell allowed the inward collapse of the electrode material, an occurrence which may have been prevented by having an internal cylindrical support to keep the contents compressed. It is suspected that the PTC activated at the higher temperatures discontinuing the current flow and further overcharge.

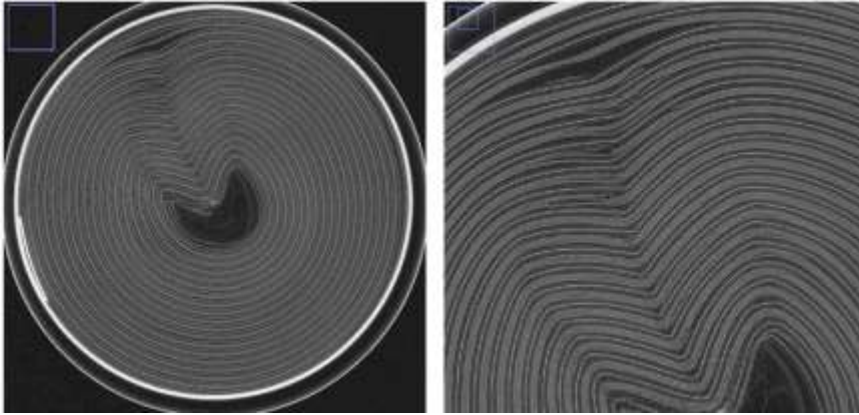
Fig. 23. Tomograph of 2.2 Ah NMC 18650 battery after thermal abuse test (after venting). Tomograph of 2.2 Ah NMC 18650 battery showing region of interest after thermal abuse test showing the presence of a gas pocket and consequent collapsed of the electrode material.

9 tomographies were taken. The dramatic changes occurred over a single tomography (where venting occurred). In the tomographies leading up to venting a thin radial-laminar gas pocket can be seen spreading between the electrode materials, Fig. 25. DVC could be used to develop a strain profile on the electrode material over time which would highlight the initiation, propagation and effects of the gas pocket formation. The collapse of the electrode material into the centre could potentially have caused short-circuiting along the line of collapse.

The sudden pressure release during venting could have caused the structural collapse. With the sudden release of pressure, the radial-laminar gas pockets could have funnelled into a path of least flow resistance causing a rapid expansion in the region as the gaseous phase intrudes upwards along the delaminated regions, similar to the formation of a diapir in geology. For simplicity, this potential phenomenon will henceforth be referred to as the '*diapir effect*'.

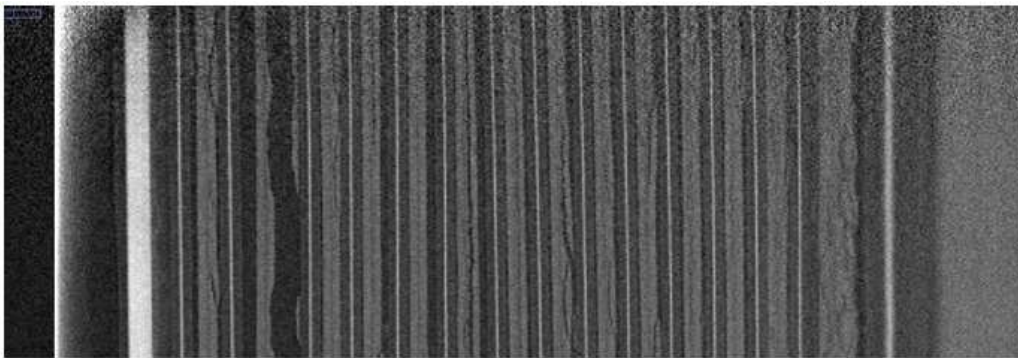
Fig. 24. Side view tomograph of 2.2 Ah NMC 18650 battery after thermal abuse test showing the presence of a gas pockets between the electrode layers.

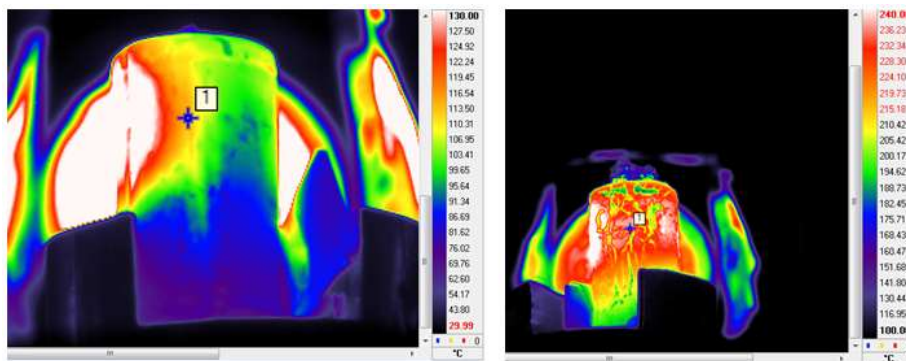
Fig. 27. Thermal image of CR2 battery during thermal abuse testing prior to venting. Thermal image of CR2 battery during thermal abuse after venting. Metallic liquid is seen bubbling from the cap of the battery.

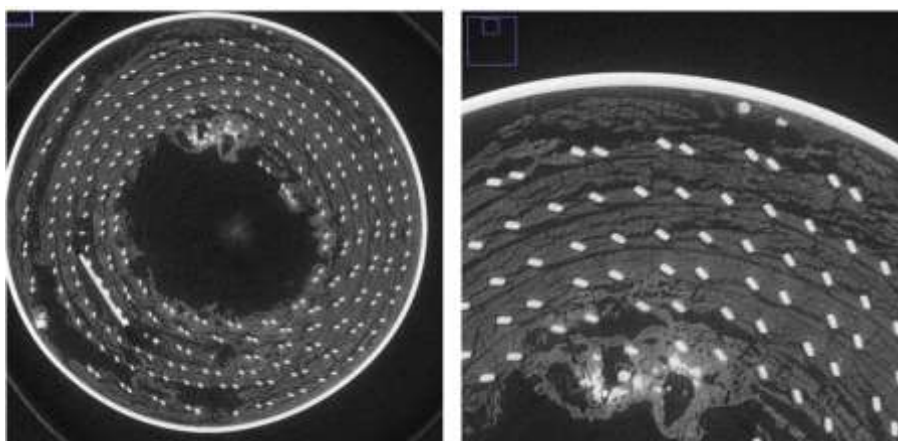
Fig. 32. Tomograph showing Duracell CR2 battery during the thermal abuse test after thermal runaway. Tomograph showing Duracell CR2 battery showing region of interest during the thermal abuse test after thermal runaway.

The MnO_2 electrode material appears to swell at an early stage of heating. The separator is expected to melt at ca. 120-150 °C which could have caused a short circuit opening a path for lithiation to occur. The consequent rapid swelling of the MnO_2 material may have been the

cause of the crack propagation. The swelling would result in unravelling of the current collecting mesh causing detachment between the mesh and the MnO_2 .

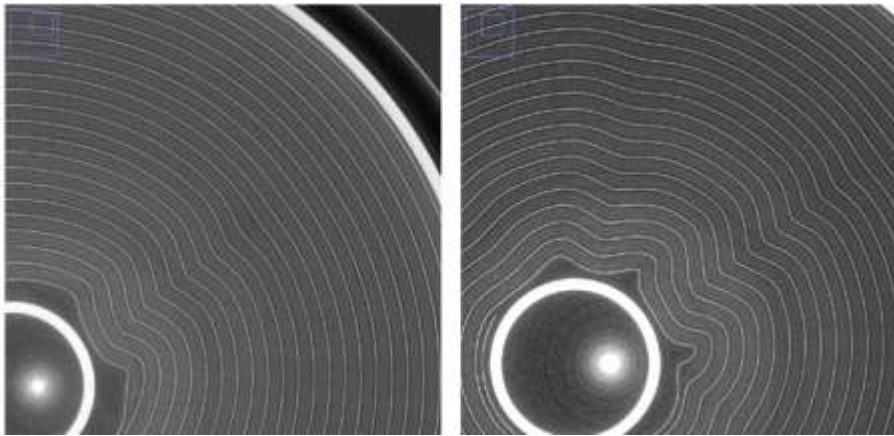
Fig. 36. Tomograph showing gradual collapse of electrode materials during thermal abuse test. Time = ca. 150 secs. Tomograph showing gradual collapse of electrode materials during thermal abuse test. Time = ca. 200 secs.

Unlike the 18650 LG NMC cells, the A123 has an internal cylindrical support which mitigates the potential '*diapir effect*' due to the sudden release of pressure during venting. The A123 design appears to maintain the mechanical integrity cell much better than the LG cells during failure.

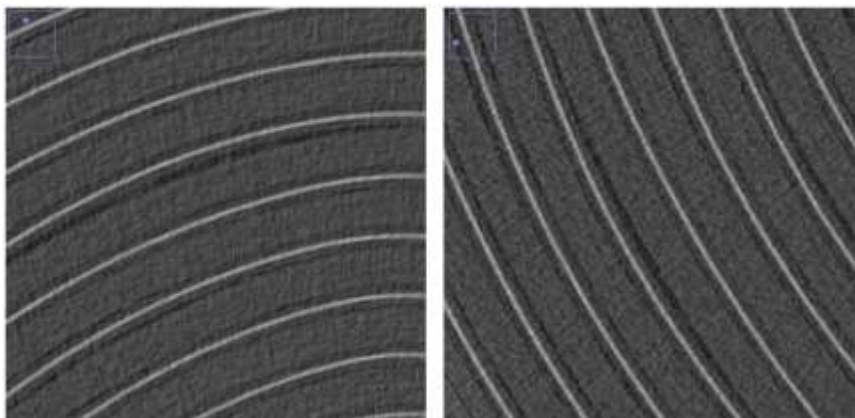
Fig. 38. Tomograph showing evidence of radial laminar gas pockets forming at the interface between the graphite and FePO_4 electrodes. Tomograph showing evidence of radial laminar gas pockets forming at the interface between the graphite and FePO_4 electrodes.

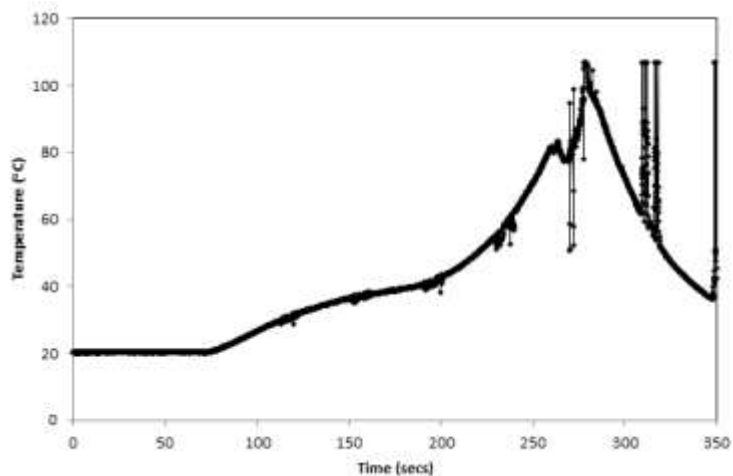
Fig. 41. Temperature at point 1 in LiPo battery during overcharging abuse test at 3 A. The sudden dip in temperature at 260 s is the point of pouch cell rupture. The surface of the cell reaches a maximum of ca. 110 °C before exploding.

The point of cell rupture can be seen from the sudden drop in temperature (ca. 5 °C) of the cell. This is expected to be as a result of the Joule-Thompson effect and can be seen for each of the battery types directly after venting. The Joule-Thomson effect for venting batteries has also been seen by Golubkov et al.⁷⁵.

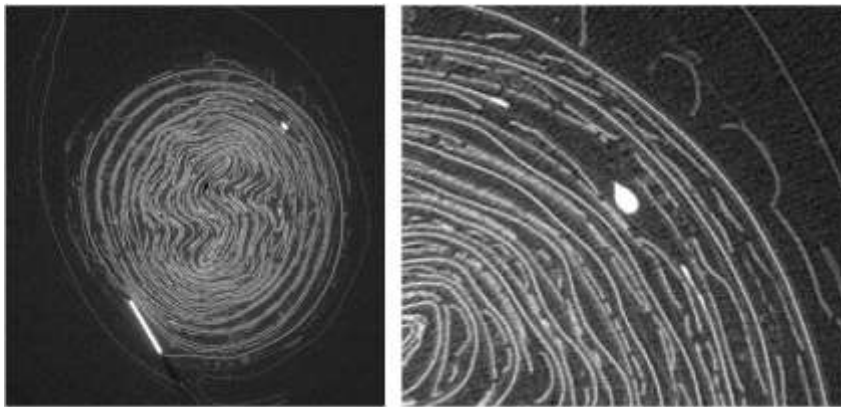
Fig. 45. Post-mortem tomograph of Turnigy 160 mAh LiPo cell after overcharge abuse test of 3 A until fail. Post-mortem tomograph showing region of interest of Turnigy 160 mAh LiPo cell after overcharge abuse test of 3 A until fail.

During overcharge abuse tests, it is expected that the oxidation of the electrolyte material will occur after ca. 4.7 V resulting in gas generation, pouch swelling and rupture. Delamination is seen between the electrode materials. The generated gas appears to seep out at the ends of the rolled cell and expands the pouch. Initially, the gas pocket formation appears to be most

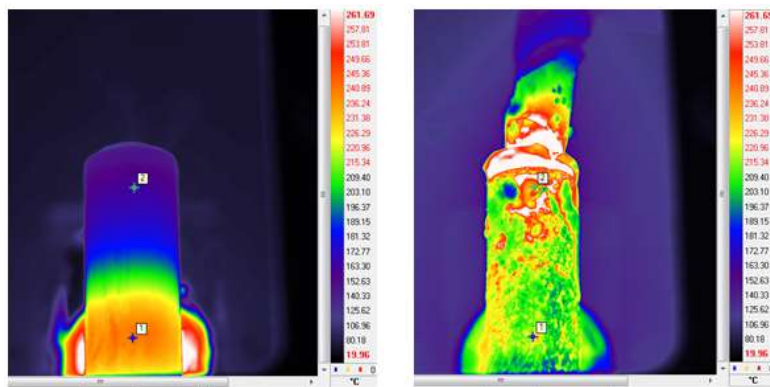
Venting at early stage. Thermal runaway when battery reached about 250 °C after ca. 2 minutes. Thermal runaway and explosion. Formation of gas pockets observed in slow tomography. Thermal runaway captured and explosion captured in radiographs.

Fig. 59. Thermal image of 18650 2.6 Ah NMC battery during extreme thermal abuse. Thermal image of 18650 2.6 Ah NMC battery after thermal runaway and explosion during extreme thermal abuse. Complete ejection of internal material occurred.

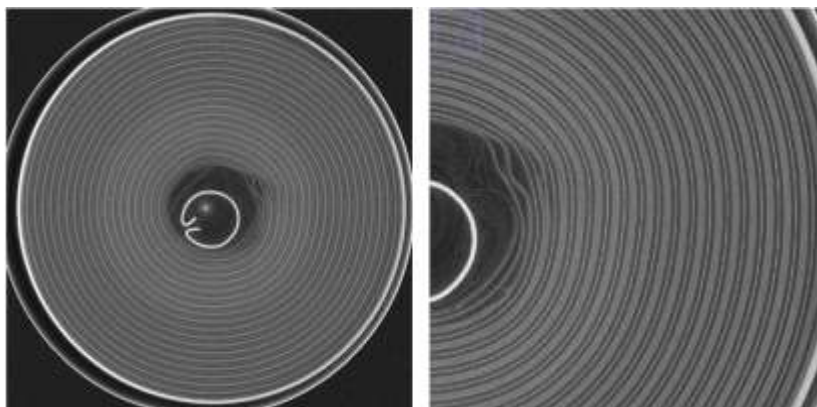
Fig. 62. Fast tomography tomograph showing the state of the battery 2 s before thermal runaway and explosion. Fast tomography tomograph showing the state of the battery in the region of interest 2 s before thermal runaway and explosion. Gas pockets appear to form in the inner regions of the electrode roll.

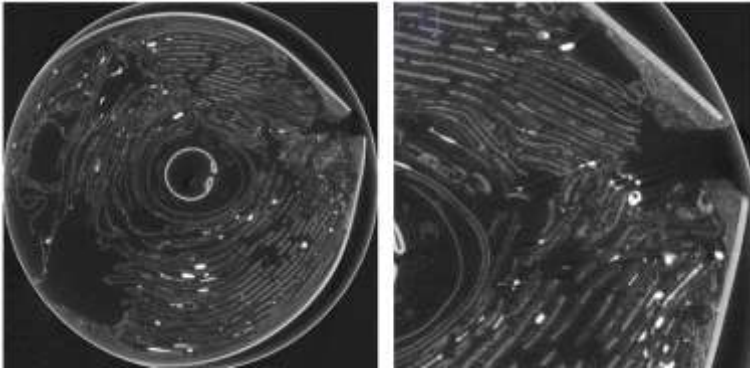
Fig. 63. Post-mortem tomograph showing the remnants of battery internals after thermal runaway. The side of the cell split open during failure. Post-mortem tomograph showing the region around the split in the shell casing after thermal runaway and explosion.

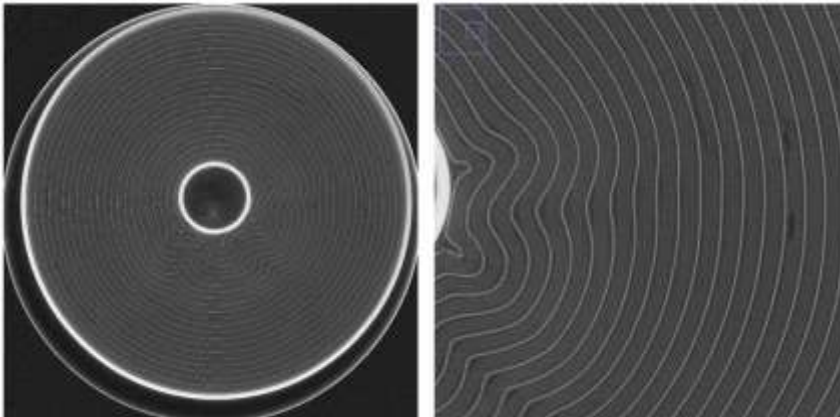
Fig. 74. Tomograph showing the state of the $A_{123} \text{FePO}_4$ battery during thermal abuse test. Tomograph focused on a region of the $A_{123} \text{FePO}_4$ battery showing evidence of structural deformation during thermal abuse test. Deformation believed to be induced from gas pocket formation.

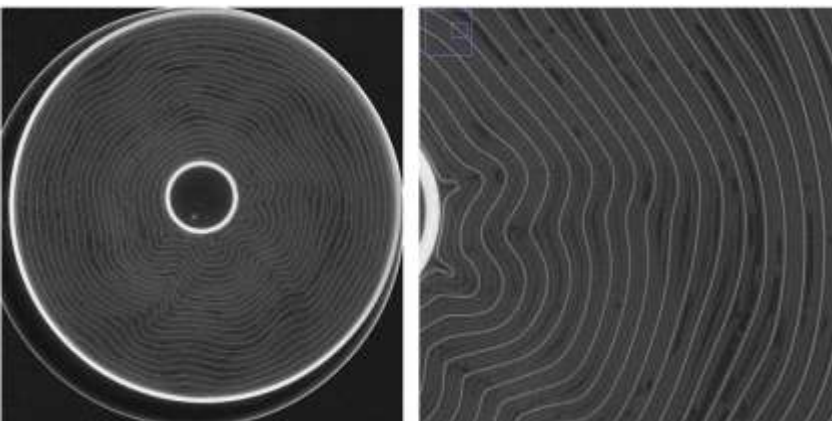
Fig. 75. Tomograph showing advanced stages of structural degradation of the $\text{Al}_{123} \text{FePO}_4$ battery during thermal abuse test, before complete thermal runaway. Tomograph showing advanced stages of structural degradation of the $\text{Al}_{123} \text{FePO}_4$ battery during thermal abuse test, before complete thermal runaway.

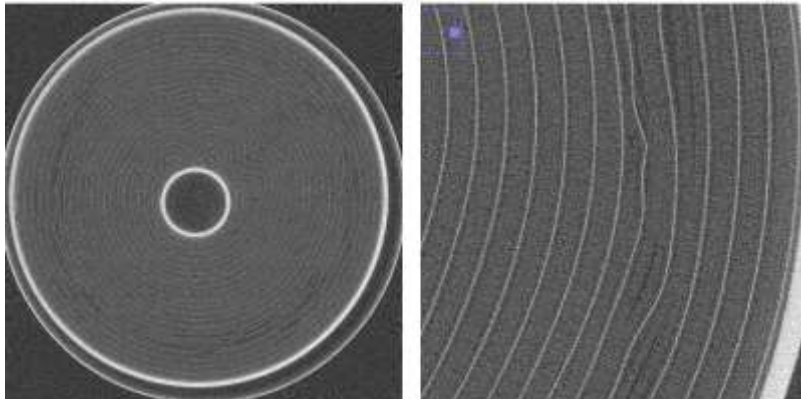
Fig. 76. Fast tomography tomograph showing the extent of degradation about 6 s before thermal runaway. Fast tomography tomograph showing evidence of delamination between the electrode and current collecting materials about 6 s before thermal runaway.

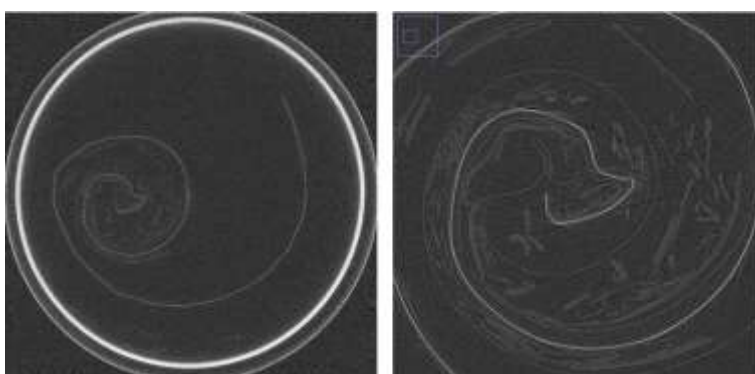
Fig. 79. Fast tomography tomography showing the remnants of the A123 FePO₄ battery after thermal runaway. Complete ejection of the battery internals occurred during thermal runaway. Fast tomography tomography showing the remnants of the A123 FePO₄ battery after thermal runaway. Complete ejection of the battery internals occurred during thermal runaway.

The A_{123} $FePO_4$ battery reached a much higher temperature (ca. 60 – 70 °C higher) than the NMC batteries before thermal runaway occurred. In addition, the presence of the internal cylindrical support appears to prevent the electrode collapse caused by the ‘*diapir*’ effect seen in the NMC cells. The A_{123} $FePO_4$ batteries appear to not only to have superior thermal stability but also superior structural support to the NMC cells, highlighting the importance of intelligent engineering.
