**Experiment title: High resolution X-ray tomography in the study of damages inside microheterogeneous materials**

**HS 69:**

ID19

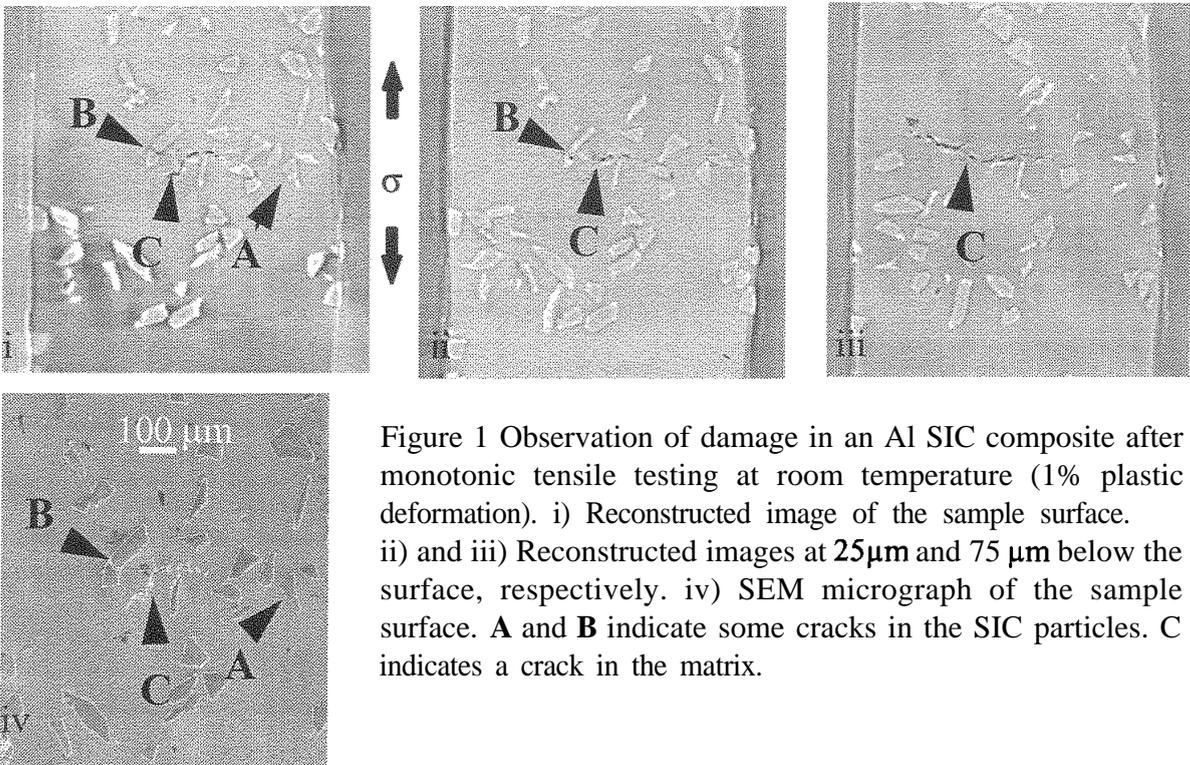
In the case of the PRC, Figure 1 shows several slices of the reconstructed 3D volume of the studied sample, after a plastic deformation of 1 %. The SiC particles are clearly identified and cracks within particles (detail A and B) or within matrix (detail C) are detected by the microtomographic method. The tomographic reconstruction of the sample surface (Figure li), is very similar to the corresponding SEM micrograph (Figure liv). Thanks to the fringe structure of phase contrast images, cracks with an opening as small as  $0.5 \mu\text{m}$ , much smaller than the experimental pixel size of  $6.6 \mu\text{m}$ , can be detected (see for example detail A on Figure li and the corresponding detail on Figure liv).

Concerning the PRC, two main damage mechanisms are observed when the plastic regime is reached: i) the cracking of the matrix on brittle oxides resulting from the processing of the material; ii) the breaking of SiC particles. Quantitative analysis of the reconstructed 3D images of the sample revealed that the aspect ratio of the broken particles along the tensile direction is high and that the damage accumulation rate is different at the surface and in the bulk of the material. As a matter of fact, HRCT reveals that a characterisation of damage restricted to the surface underestimates the number of broken particles by a factor 4.

Figure 1 Observation of damage in an Al SiC composite after monotonic tensile testing at room temperature (1% plastic deformation). i) Reconstructed image of the sample surface. ii) and iii) Reconstructed images at  $25 \mu\text{m}$  and  $75 \mu\text{m}$  below the surface, respectively. iv) SEM micrograph of the sample surface. A and B indicate some cracks in the SiC particles. C indicates a crack in the matrix.
