ASSESSMENT OF DAMAGE EVOLUTION IN MODEL METAL MATRIX COMPOSITE BY X-RAY MICROTOMOGRAPHY

HS 896

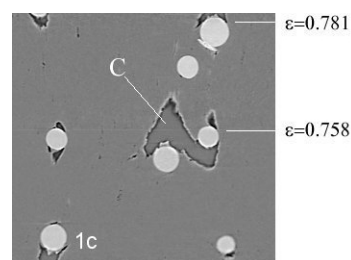
Three reconstructed images are shown below to complement the abstract. They show the same longitudinal slice at three deformed stages (initial state and two deformed states, the second one presents a gradient of deformation due to the necking of the sample). In figure 1a, detail A presents a pre-existed hole at the particle/matrix interface. Decohesion appears in figure 1b (detail B). This hole grows and finally interlinks with other voids, as shown by detail C in figure 1c.

**Abstract**—Damage mechanisms of model materials have been studied using in situ tensile tests coupled with high resolution X-ray tomography. This non destructive technique revealed that 50% of the particles were pre-damaged by the extrusion. The initiation and growth phases of the damage process were quantified using the three dimensional images. The growth phase, measured both locally (on isolated particles) and globally (in the entire block) was compared with the Rice and Tracey prediction which was shown to overestimate the global prediction and to give a reasonable agreement of the local growth rate. Discrepancies between prediction and experiments could be partly quantified by introducing the effect of the growth threshold in the Rice and Tracey analysis. The scatter in the measured thresholds and growth rates were attributed to local crystallography and to local spatial arrangement effects. **2001 Published by Elsevier Science Ltd on behalf of Acta Materialia Inc.**
