Experiment title: Creep damage of Magnesium based Metal Matrix Composites	Experiment number: MA-749
Beamline: ID19	Date of experiment: From: 15.04.2009 to: 19.04.2009	Date of report: 23.8.2010
Shifts: 12	Local contact(s): Elodie Boller	<i>Received at ESRF:</i>
Names and affiliations of applicants (* indicates experimentalists): *Bettina Camin, TU Berlin, Metallic Materials, Sekr. BH18, 10587 Berlin, Germany *Dimas Souza, TU Berlin, Metallic Materials, Sekr. BH18, 10587 Berlin, Germany *Lisa Chen, TU Berlin, Metallic Materials, Sekr. BH18, 10587 Berlin, Germany Walter Reimers, TU Berlin, Metallic Materials, Sekr. BH18, 10587 Berlin, Germany

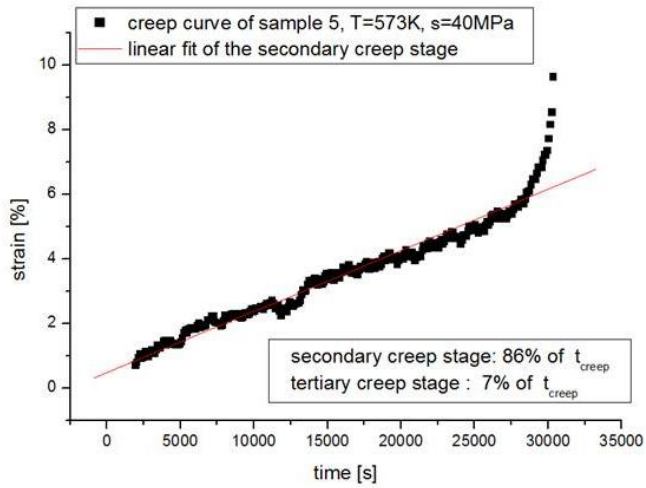
Fig. 1 creep curve of sample 5, $T=573K$, $\sigma=40MPa$

Fig. 1 shows the creep curve of sample 5 ($T=573\text{K}$, $\sigma=40\text{MPa}$) which is representative for all investigated samples. All samples exhibited a long secondary creep stage and a short tertiary creep stage independent from the respective temperature-load-regime. The strain of the sample is nearly 10% and the whole creep time was $t_{\text{creep}}=511\text{min}$.

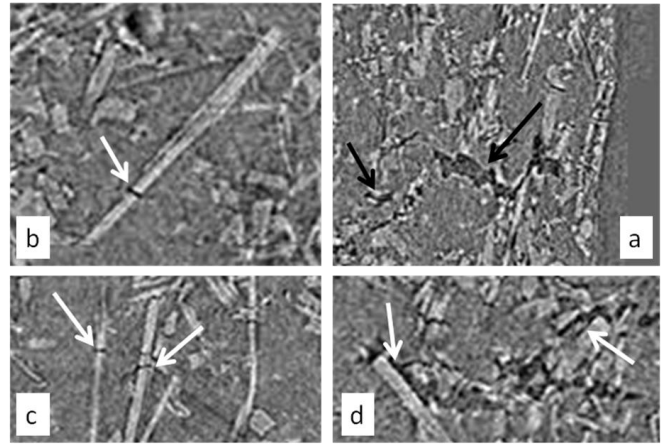
Fig. 3 sample 5, $T=573K$, $\sigma=40MPa$, $t_{creep}=505min$
a) cracks and pores in the matrix, b,c) cracks in the fibre reinforcement,
d) delamination of reinforcements

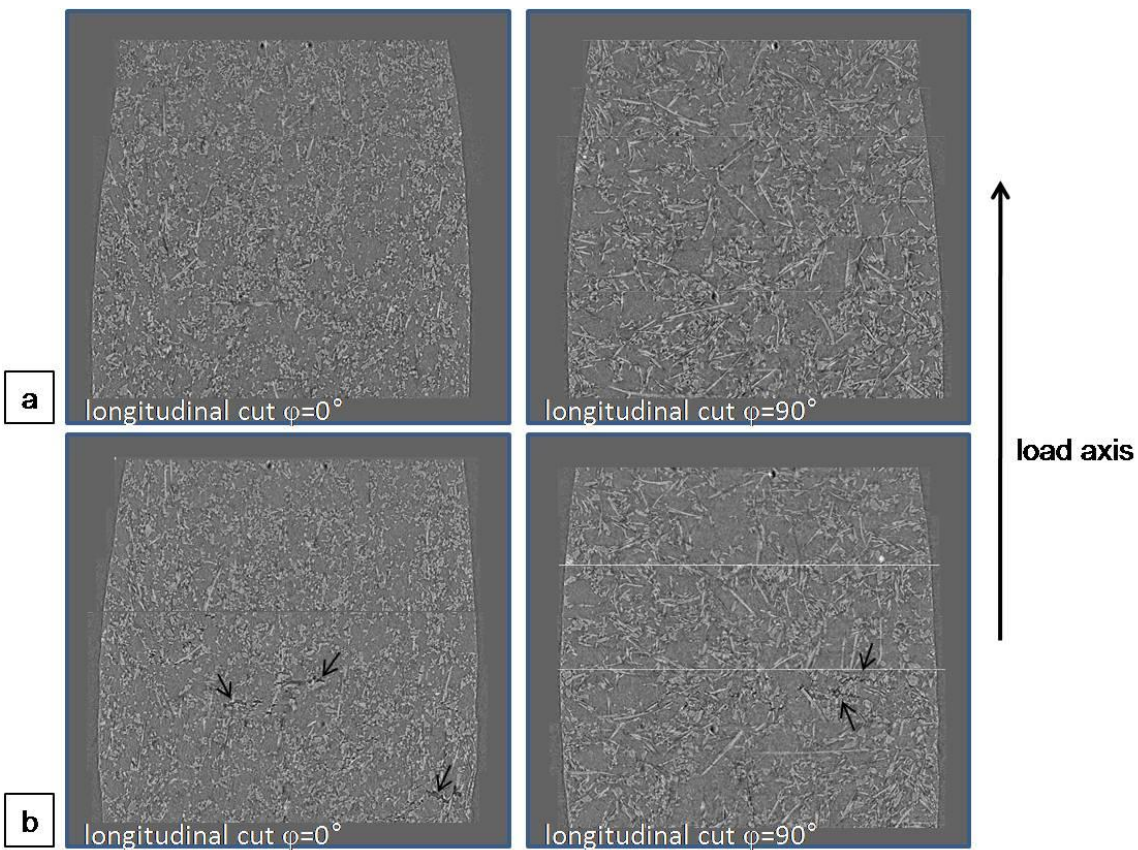
Fig. 2 sample 5, $T=573K$, $\sigma=40MPa$, a) initial state
b) last tomogram before fracture at $t_{creep}=505min$

Fig. 2 shows 2D longitudinal cuts at $\varphi=0^\circ$ and $\varphi=90^\circ$ of the tomogram of the sample 5 ($T=573\text{K}$, $\sigma=40\text{MPa}$) at the initial state and the last tomogram before fracture at $t_{\text{creep}}=505\text{min}$. The comparison of longitudinal cuts at $\varphi=0^\circ$ and $\varphi=90^\circ$ illustrates the planar distribution of the short fibre reinforcement. In the initial state small pores located at reinforcement agglomeration caused by the manufacturing process can be detected. Only few cracks in the fibre reinforcement were found. By comparing the longitudinal cuts of the initial state and the last tomogram before fracture the growth of pores and presence of cracks in the matrix (Fig. 2b, black arrows, Fig. 3a, black arrows) and the increasing number of cracks of the short fibre reinforcement were observed (Fig. 3b and 3c, white arrows). Delamination of the reinforcements were detected, too (Fig. 3d, white arrows). Further evaluations of the experimental data in view of the quantitative analyses of the time dependent reinforcement delaminations, pore evolutions and crack formations are still under way.
