1. Summary of MA2117 Experiment, ID15, May 2014

Numerous tests involving a range of operating and abuse conditions were performed with the ultimate aim of comparing the behaviour of different cell types and chemistries over various conditions.

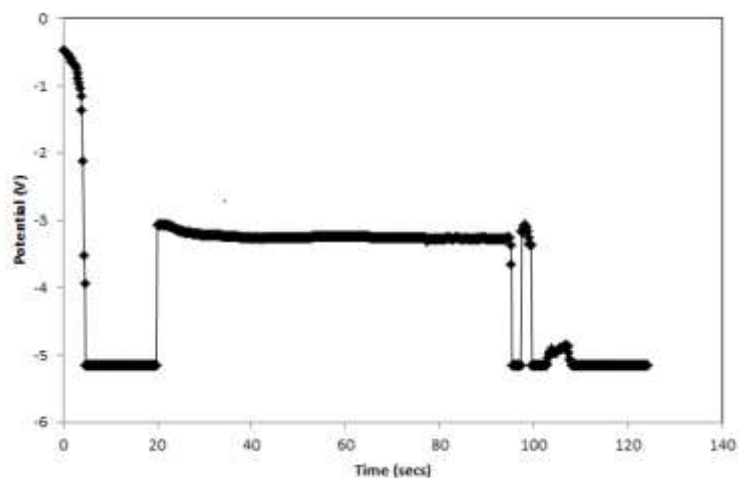
Temperature reached ca. 200 °C, gas generation with swelling, thermal runaway.

Fig. 1. Cell potential curve during rapid discharge.

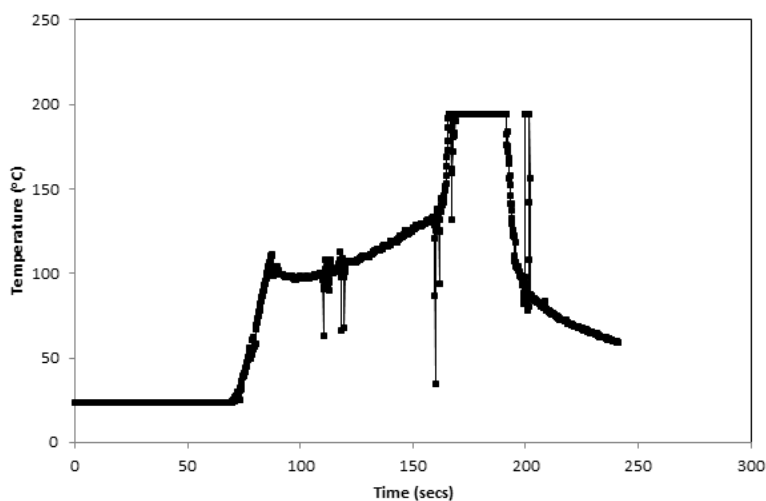
Fig. 3. Temperature reading at point 1 during rapid discharge. The point of rupture and thermal runaway are seen by the two sudden changes in thermal behaviour. The thermal camera was limited to 190 °C for this experiment; hence the peak temperature during thermal runaway was not captured but was >200 °C.

Rapid discharge of the LiPo cells resulted in significant heating causing the batteries to reach $>100\text{ }^{\circ}\text{C}$ before thermal runaway. The gas evolution resulting from the vaporisation of electrolyte material caused the pouch to swell and the electrodes to delaminate.

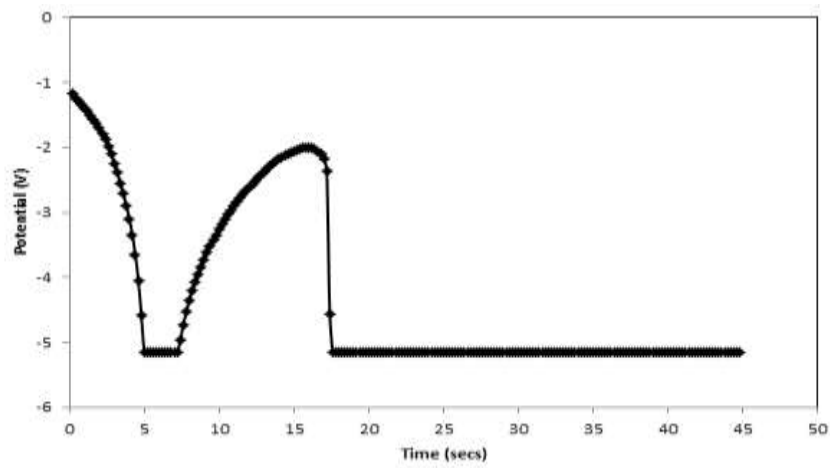
Fig. 6. Potential curve during 8 A rapid discharge of CR2 battery.

Over 17 s of 8 A discharge there was no noticeable change in the electrode structure and no visible evidence of degradation. The increasing potential over the first 5 s indicates an increase in resistance potentially caused by the PTC. This would have limited the current flowing through the device. The region of the PTC in the thermal images appears to get significantly hotter than the main body of the battery which also indicates the activity of the PTC.

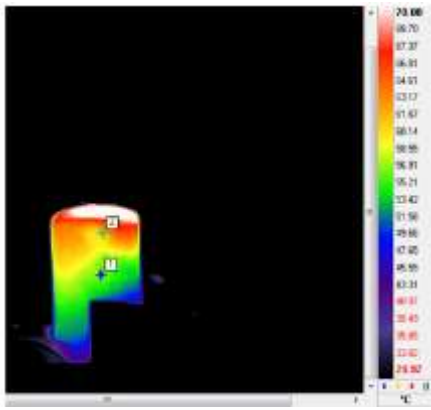
Fig. 7. Thermal image showing temperature gradient across Duracell CR2 battery during rapid (8 A) discharge.

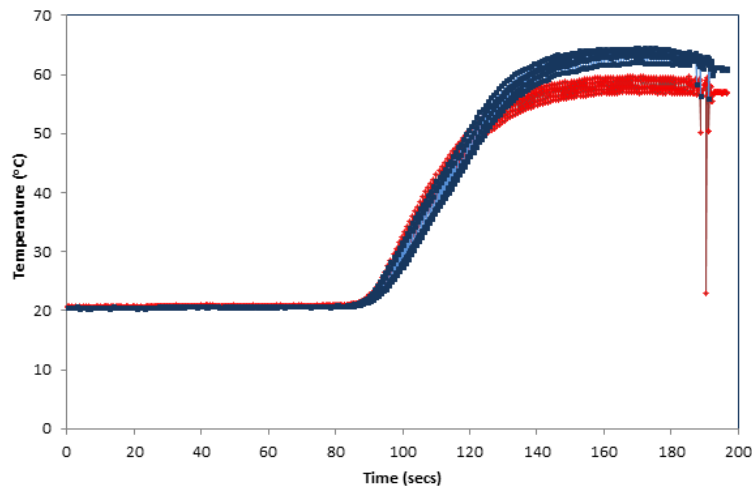
Fig. 8. Temperature reading at point 1 and 2 during 8 A rapid discharge of Duracell CR2 battery.

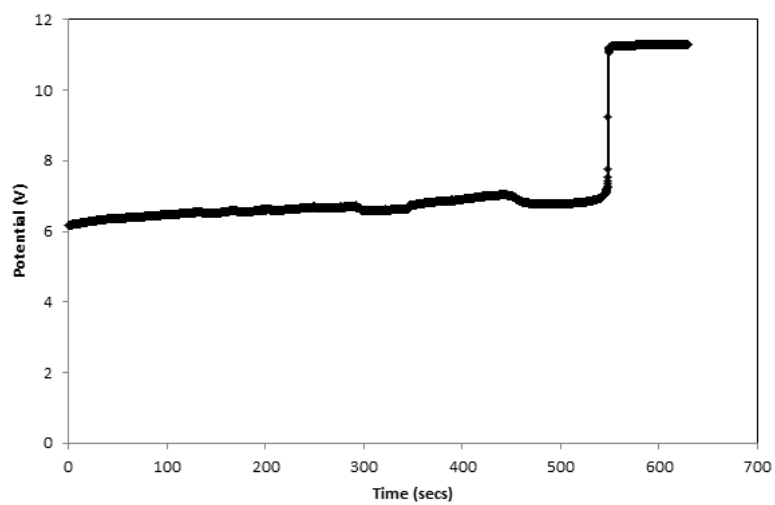
Voltage and temperature rise to ca. 60 °C followed by circuit breaking and cooling. Apparent gas pocket between the electrode and separator layers.

Fig. 10. Battery potential during galvanostatic overcharging at 6A of an 18650 2.2 Ah NMC battery.

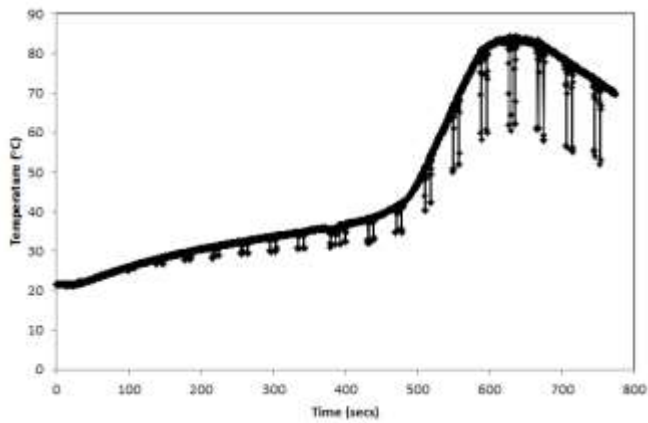
Fig. 12. Temperature reading from point 1 during 6 A overcharging of 18650 2.2 Ah NMC battery.

16 tomographies captured the progression of this degradation. Rapid heat was observed after ca. 500 s potentially caused by exothermic electrolyte degradation reactions. The lack of internal support in the 2.2 Ah NMC cell allowed the inward collapse of the electrode material, an occurrence which may have been prevented by having an internal cylindrical support to keep the contents compressed. It is suspected that the PTC activated at the higher temperatures discontinuing the current flow and further overcharge.

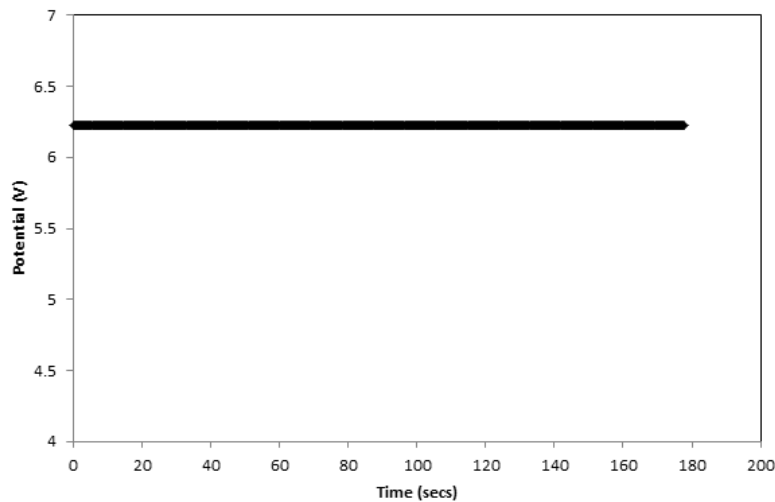
Temperature at cap rose rapidly. After about 50 secs the current stopped. Experiment was stopped and battery was allowed to cool down before repeating the experiment. Repeated 5 times. PTC limited effect of rapid charge.

Fig. 15. Potential curve during charging. There appears to be an error in the readings for this test.

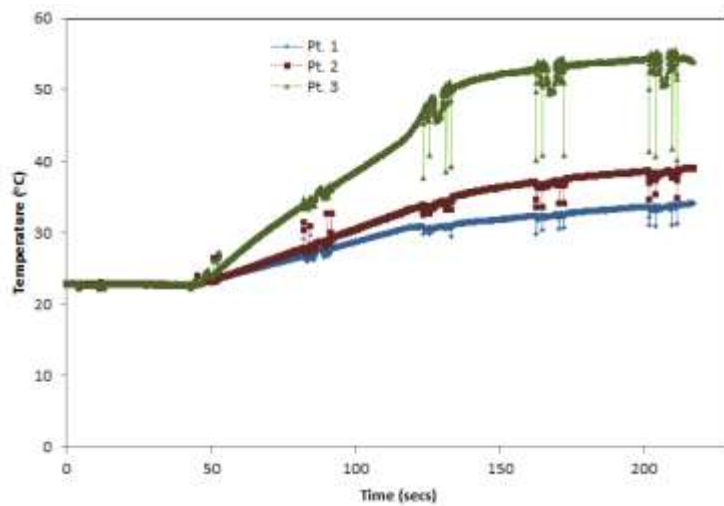
Fig. 17. Temperature at the three points along the batteries surface in the previous image during heating.

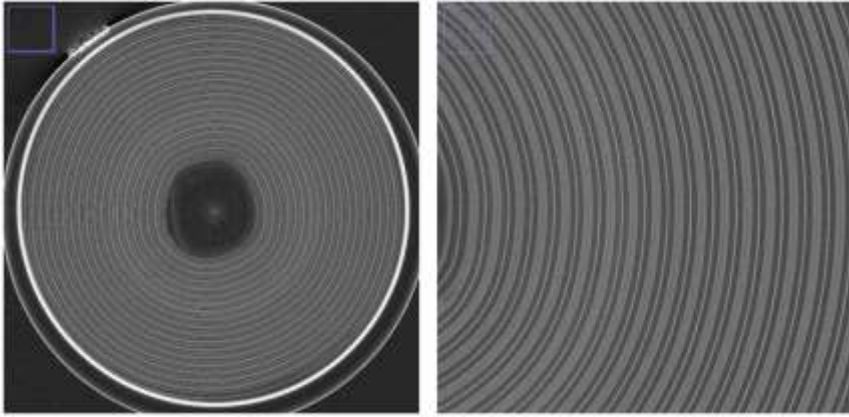
Fig. 18. Tomograph showing the state of a 2.2 Ah 18650 NMC battery after the first charge.
Tomograph showing a focused region of a 2.2 Ah 18650 NMC battery after the first charge.

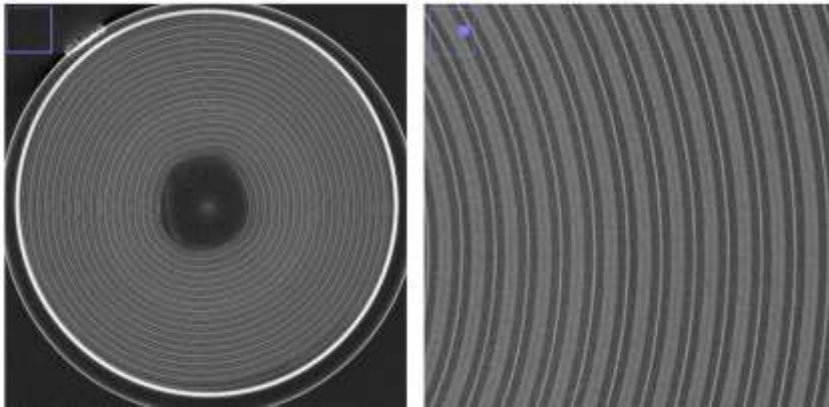
Fig. 19. Tomograph showing the state of a 2.2 Ah 18650 NMC battery after the fifth charge.
Tomograph showing a focused region of a 2.2 Ah 18650 NMC battery after the fifth charge.

No noticeable change was seen over the 5 rapid charging processes. The battery was operated within the recommended operating voltages and the PTC device prevented overheating, therefore no gas generation was expected. Applying DVC to sequential images may reveal non-uniform expansion of the electrode material. During rapid charging it is expected that electrode swelling would mostly occur nearest the surface causing uneven strain fields throughout the NMC electrode material. The magnitude of swelling being greater near the surface would indicate lithium diffusion induced strain fields.

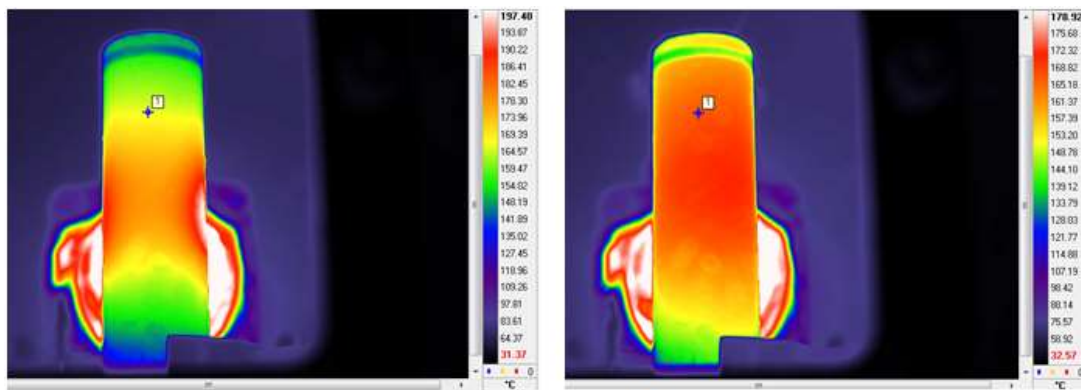
Battery reached about 160 °C before venting. Expected SEI breakdown, gas generation - venting of gases and electrolyte.

Fig. 20. Thermal image during heating of 18650 2.6 Ah NMC battery. Image is prior to venting.
Thermal image during heating of 18650 2.6 Ah NMC battery. Image taken after venting and heat gun turned off.

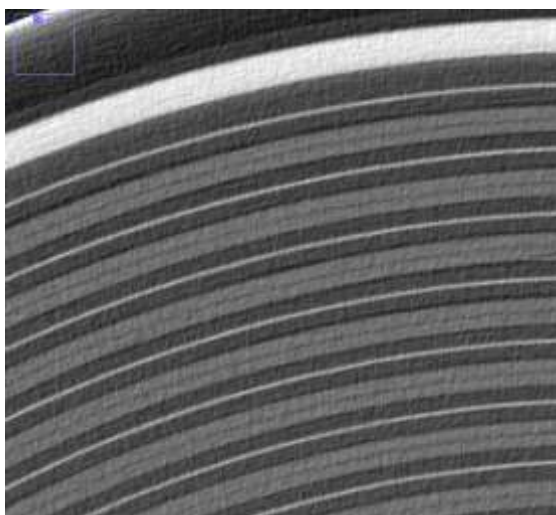
Fig. 25. Tomography of region of interest showing the formation of a thin gas pocket between the electrodes.

9 tomographies were taken. The dramatic changes occurred over a single tomography (where venting occurred). In the tomographies leading up to venting a thin radial-laminar gas pocket can be seen spreading between the electrode materials, Fig. 25. DVC could be used to develop a strain profile on the electrode material over time which would highlight the initiation, propagation and effects of the gas pocket formation. The collapse of the electrode material into the centre could potentially have caused short-circuiting along the line of collapse.

The sudden pressure release during venting could have caused the structural collapse. With the sudden release of pressure, the radial-laminar gas pockets could have funnelled into a path of least flow resistance causing a rapid expansion in the region as the gaseous phase intrudes upwards along the delaminated regions, similar to the formation of a diapir in geology. For simplicity, this potential phenomenon will henceforth be referred to as the '*diapir effect*'.

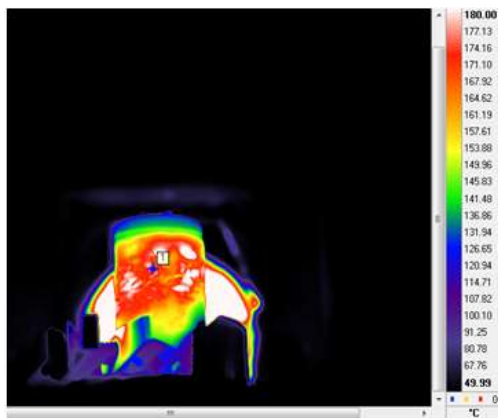
Cable came loose during experiment making the thermal readings difficult to capture during rotation periods. Battery exploded at ca. 180 °C. Expected SEI breakdown, separator melts, internal short, Li melts - venting, spitting and potentially sparks from the escaping molten Li.

Fig. 26. Thermal image of CR2 battery during heating.

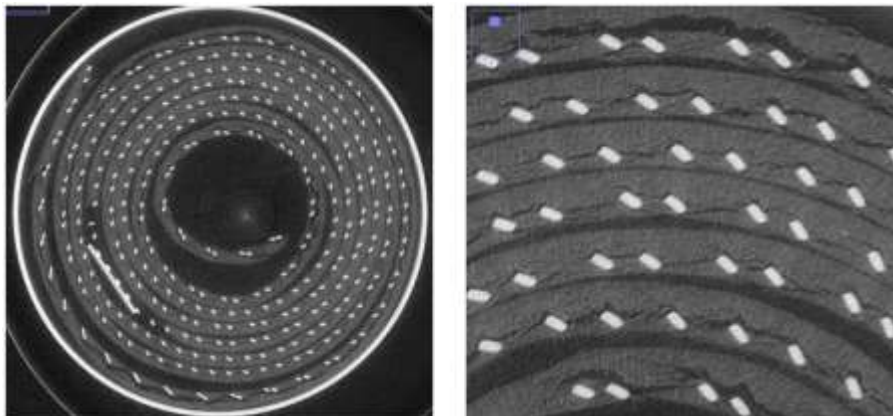
Fig. 30. Tomograph showing Duracell CR2 battery during the thermal abuse test before thermal runaway. Tomograph showing Duracell CR2 battery showing region of interest during the thermal abuse test before thermal runaway.

The MnO_2 electrode material appears to swell at an early stage of heating. The separator is expected to melt at ca. 120-150 °C which could have caused a short circuit opening a path for lithiation to occur. The consequent rapid swelling of the MnO_2 material may have been the

cause of the crack propagation. The swelling would result in unravelling of the current collecting mesh causing detachment between the mesh and the MnO_2 .

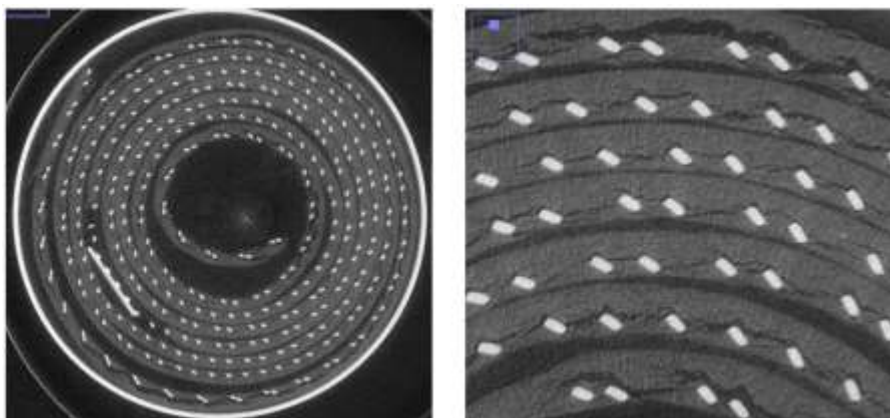
Fig. 31. Tomograph showing Duracell CR2 battery during the thermal abuse test before thermal runaway. Tomograph showing Duracell CR2 battery showing region of interest during the thermal abuse test before thermal runaway.

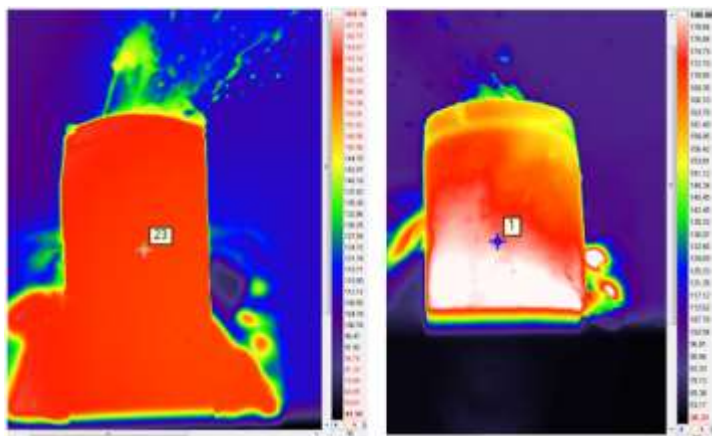
A123 vented at 120 °C. Heat gun turned off. Spewing and bubbling continued for ca. 5 mins keeping at ca. 115 °C. Battery cooled down thereafter.

Fig. 33. Thermal image of 18650 A123 FePO_4 battery during venting. Venting occurred after 340

secs. (Temperature peaked for $A_{123}Ch_{120}CHG$) Thermal image of 18650 $A_{123}FePO_4$ battery during venting. Venting occurred after 405 secs. ($A_{123}Ch_{120}C_b$)

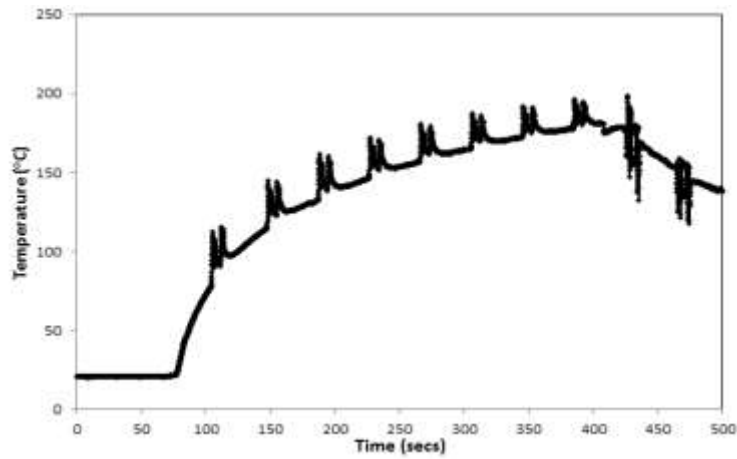
Fig. 34. Temperature at point 23 during thermal abuse of 18650 $A_{123}FePO_4$ battery. Venting occurs after 405 s where the temperature fluctuation occurs.

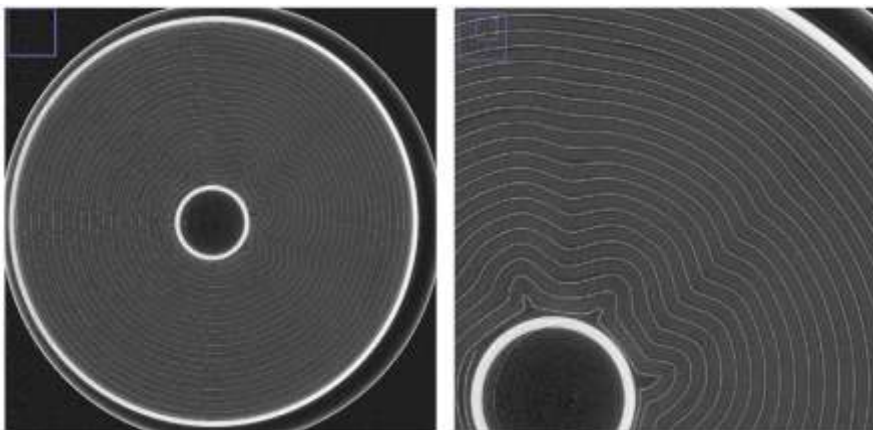
Fig. 37. Tomograph of FePO_4 A123 18650 battery after thermal abuse test. Tomograph showing region of interest of FePO_4 A123 18650 battery after thermal abuse test.

Unlike the 18650 LG NMC cells, the A123 has an internal cylindrical support which mitigates the potential '*diapir effect*' due to the sudden release of pressure during venting. The A123 design appears to maintain the mechanical integrity cell much better than the LG cells during failure.

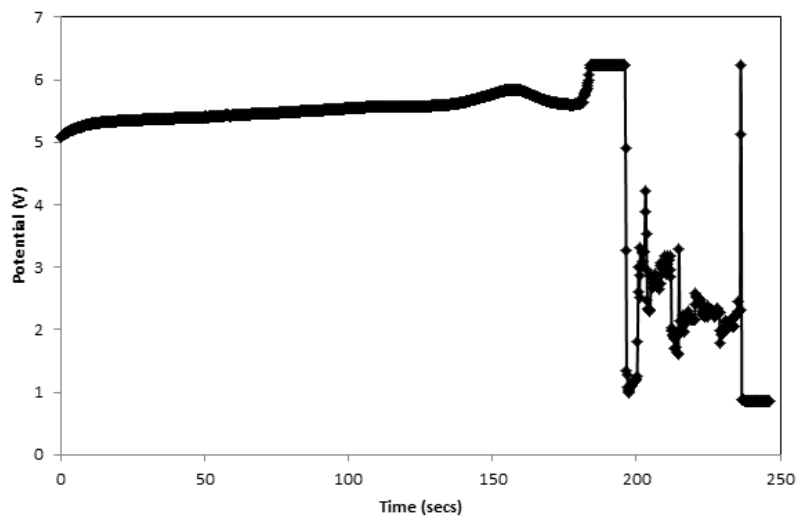
The 40 second period over which swelling, rupture and thermal runaway occurs can be identified by the distortions in the potential curve.

Fig. 39. Cell potential during overcharge of LiPo cells.

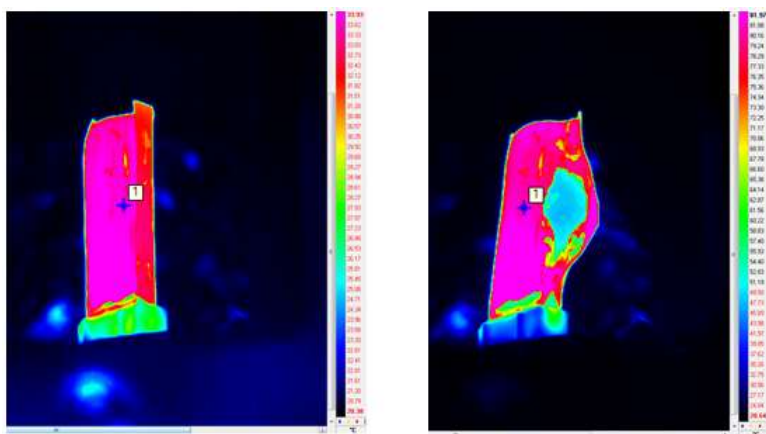
Fig. 40. Thermal image of LiPo battery during overcharging abuse test at 3 A. Thermal image of LiPo battery after pouch rupture during overcharging abuse test at 3 A.

The point of cell rupture can be seen from the sudden drop in temperature (ca. 5 °C) of the cell. This is expected to be as a result of the Joule-Thompson effect and can be seen for each of the battery types directly after venting. The Joule-Thomson effect for venting batteries has also been seen by Golubkov et al.⁷⁵.

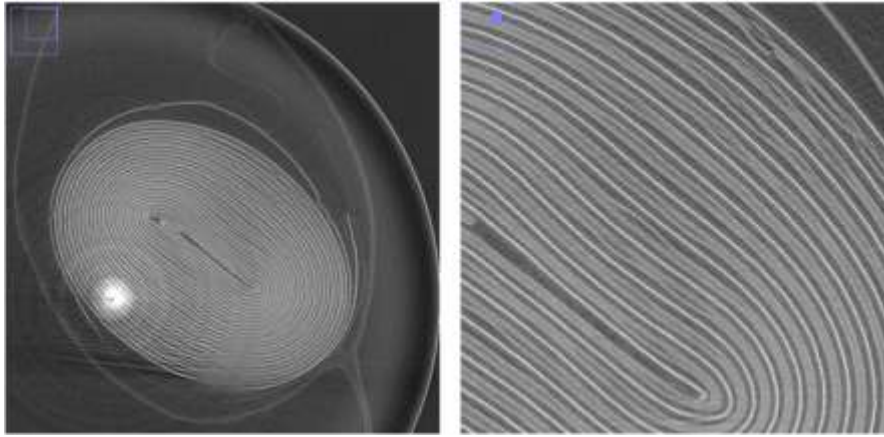
Fig. 44. Tomograph of Turnigy 160 mAh LiPo cell during overcharge abuse test of 3 A until fail. Tomograph showing region of interest of Turnigy 160 mAh LiPo cell during overcharge abuse test of 3 A until fail.

During overcharge abuse tests, it is expected that the oxidation of the electrolyte material will occur after ca. 4.7 V resulting in gas generation, pouch swelling and rupture. Delamination is seen between the electrode materials. The generated gas appears to seep out at the ends of the rolled cell and expands the pouch. Initially, the gas pocket formation appears to be most

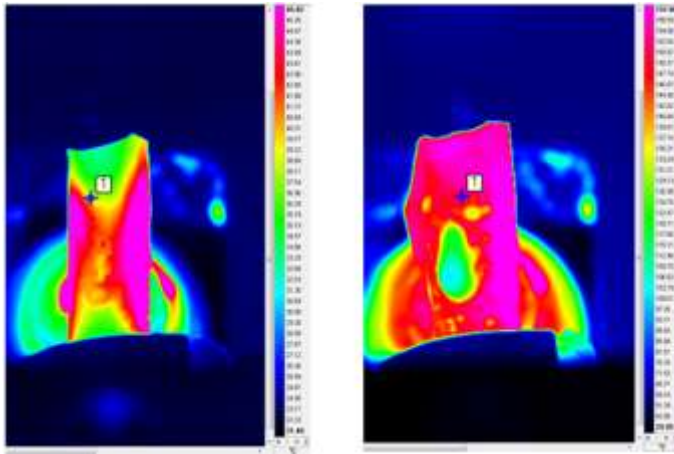
Battery heated rapidly, swelled and burst. Artefact in the centre of the image – use different flat field during reconstruction.

Fig. 46. Thermal image of LiPo cell during thermal abuse test. Thermal image of LiPo cell after venting during thermal abuse test.

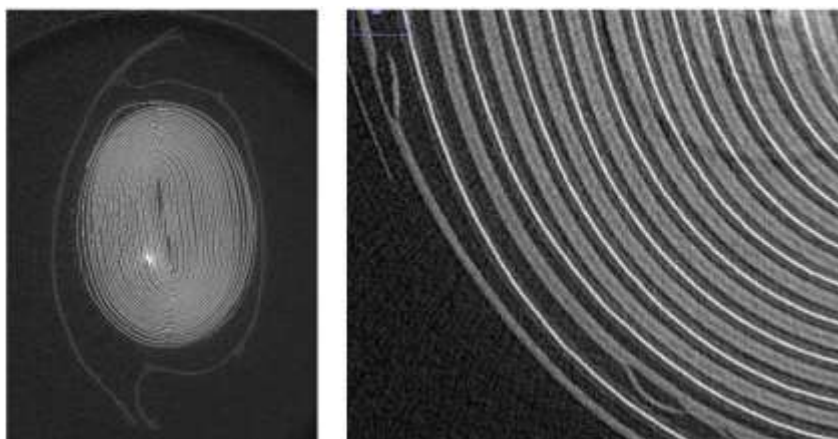
Fig. 49. Tomograph of Turnigy 160 mAh LiPo cell after thermal abuse test. Tomograph of Turnigy 160 mAh LiPo cell showing region of interest after thermal abuse test.

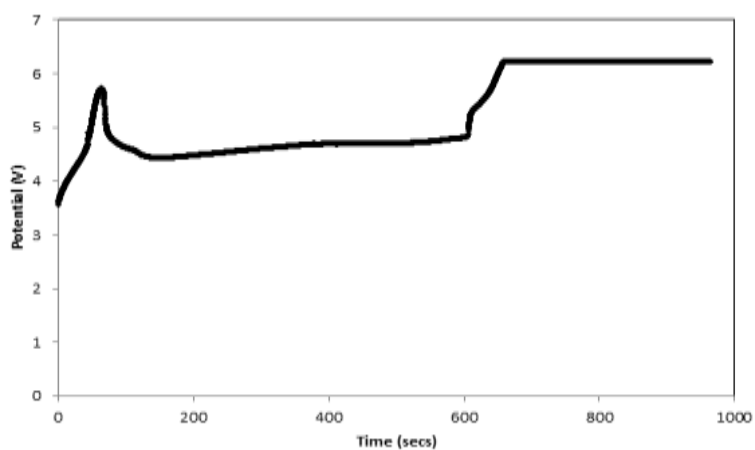
Interesting potential curve. Temperature reached ca. 80 °C before venting and cooling. After cooling voltage returned to normal and slowly increased over time - possible due to lithium diffusion of lithium plating.-worth testing in lab.

Fig. 50. Cell potential during overcharge of CR2 battery.

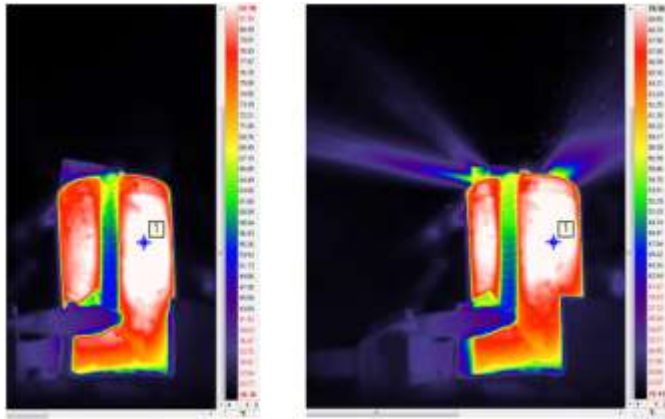
Fig. 51. Thermal image during overcharging of Duracell CR2 battery at 1 A. Thermal image showing venting of Duracell CR2 battery during overcharge abuse test.

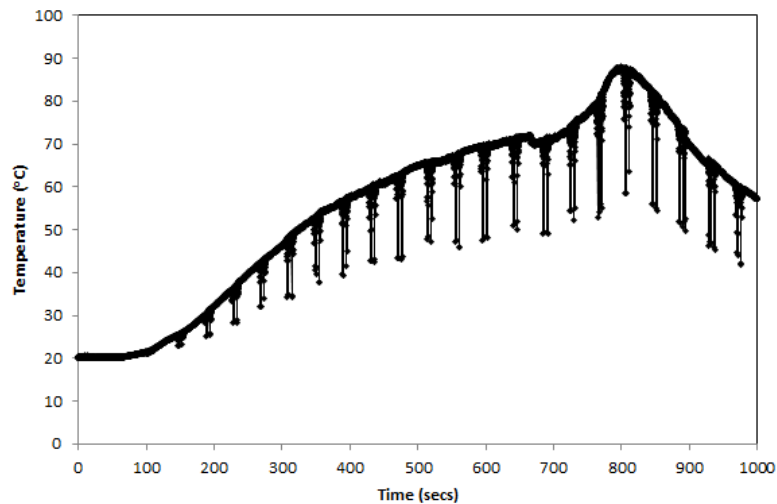
Fig. 52. Temperature reading from point 1 during overcharge of Duracell CR2 battery at 1 A. The slight dip in temperature at ca. 680 secs shows the point at which the cell vents.

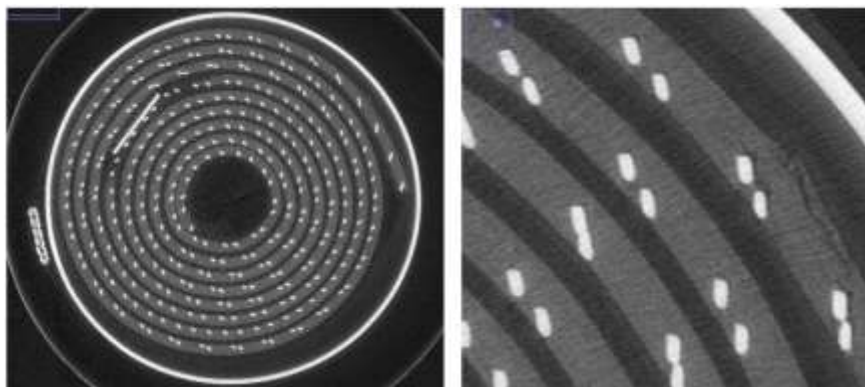
Fig. 53. Tomograph of Duracell CR2 battery before overcharge abuse test at 1 A. Tomograph showing region of interest of Duracell CR2 battery before overcharge abuse test at 1 A.

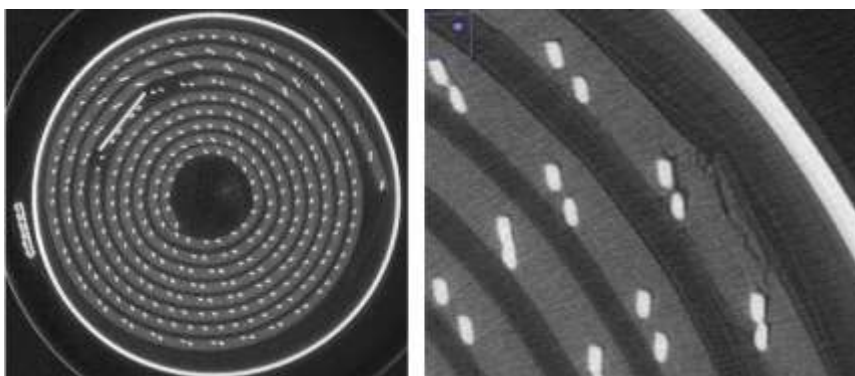
Fig. 54. Tomograph of Duracell CR2 battery after overcharge abuse test at 1 A. Tomograph showing region of interest of Duracell CR2 battery after overcharge abuse test at 1 A.

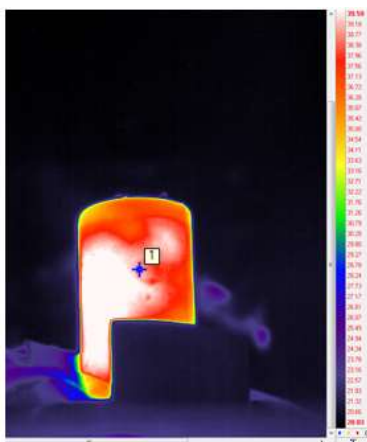
Fig. 55. Thermal image of rapid overcharge abuse test of Duracell CR2 battery.

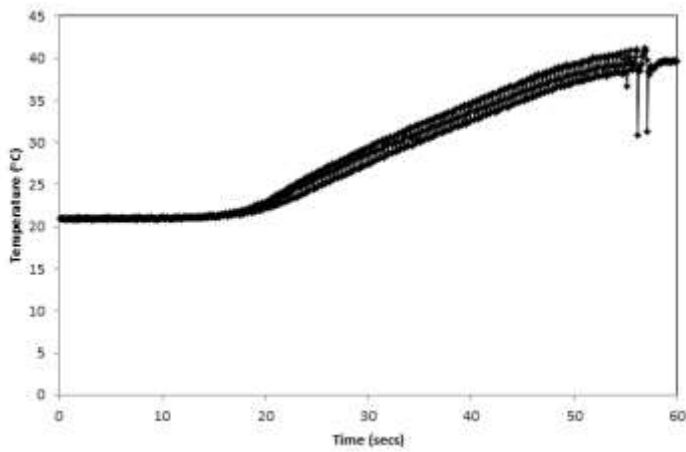
Fig. 56. Temperature at point 1 during rapid overcharge of Duracell CR2 battery.

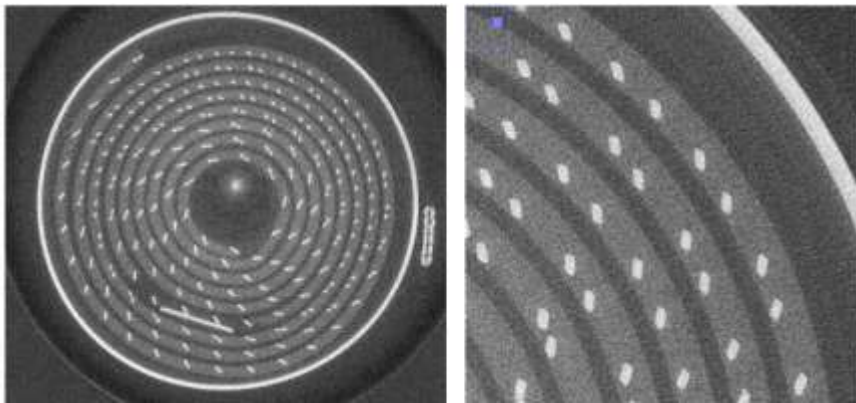
Fast tomo limited experiment to 17 s during which time no significant change was observed in the images.

Fig. 57. Tomograph of Duracell CR2 battery after overcharge abuse test at 3 A captured with fast tomography. Tomograph showing region of interest of Duracell CR2 battery before overcharge abuse test at 3 A captured with fast tomography.

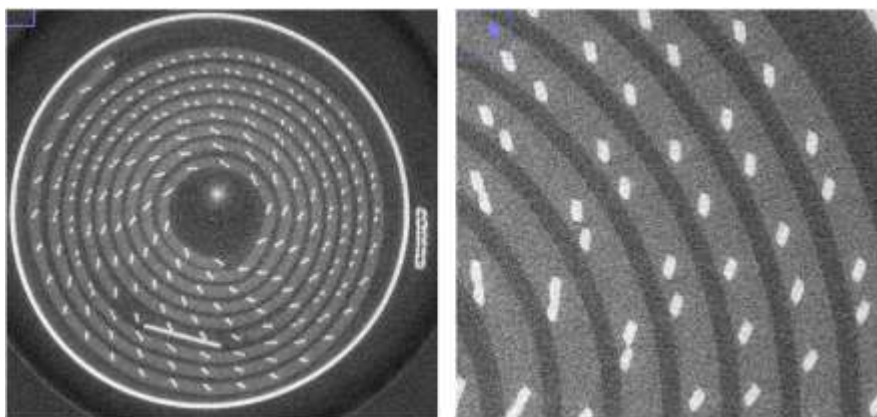
Fig. 58. Tomograph of Duracell CR2 battery after overcharge abuse test at 3 A captured with fast tomography. Tomograph showing region of interest of Duracell CR2 battery after overcharge abuse test at 3 A captured with fast tomography.

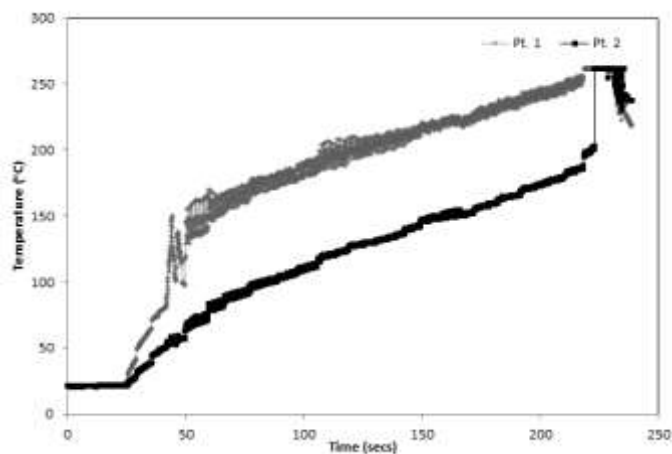
Fig. 60. Temperature at point 1 and 2 during extreme thermal abuse of 18650 2.6 Ah NMC batteries. Thermal camera readings were limited to 260 °C. The final temperature of the battery shell was not captured. The apparent presence of melted copper globules in the post mortem tomographies indicate that temperatures reached >1000 °C inside the battery casing.

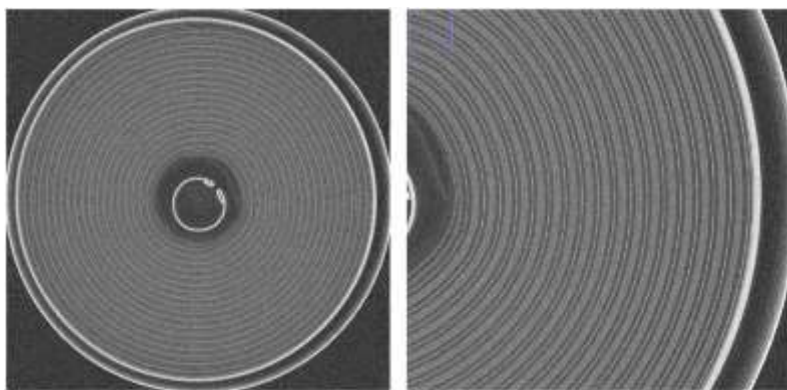
Fig. 61. Slow tomography tomograph showing LG 2.6 Ah NMC battery before thermal abuse test. Slow tomography tomograph showing region of interest of LG 2.6 Ah NMC battery before thermal abuse test.

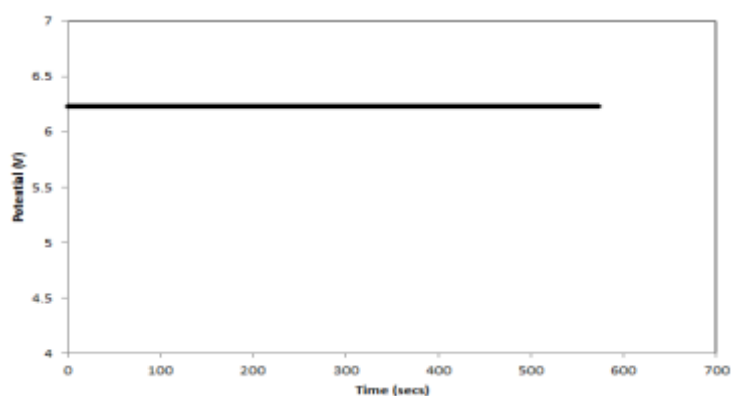
Fig. 67. Cell potential during overcharge. There appears to be an error in the readings.

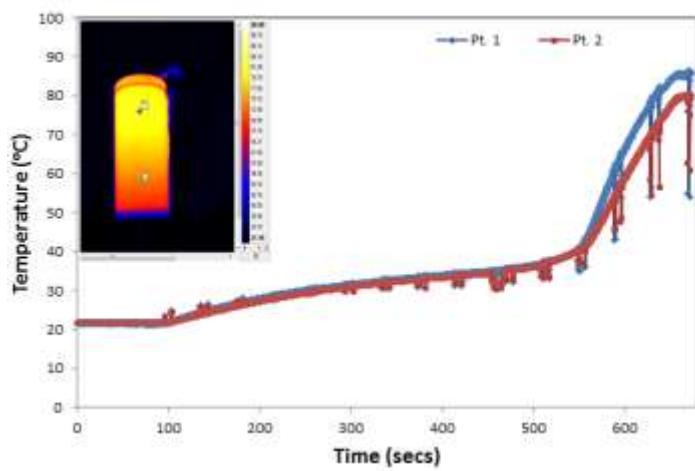
Fig. 68. Temperature of NMC cell during overcharge test.

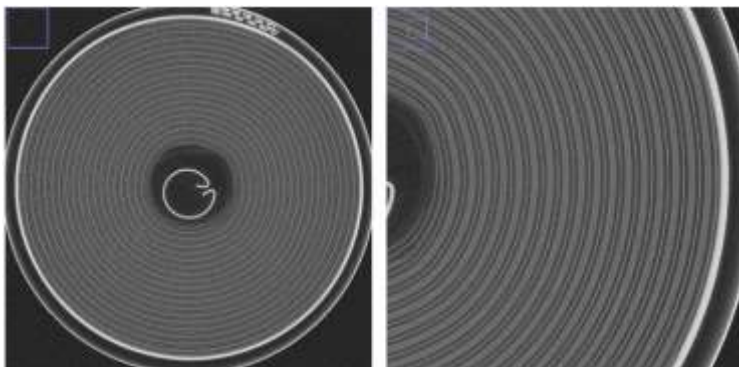
Fig. 69. Tomography of the 2.6 Ah 18650 NMC cell before thermal and electrical abuse test. Tomography showing a focused region of the 2.6 Ah 18650 NMC cell before thermal and electrical abuse test.

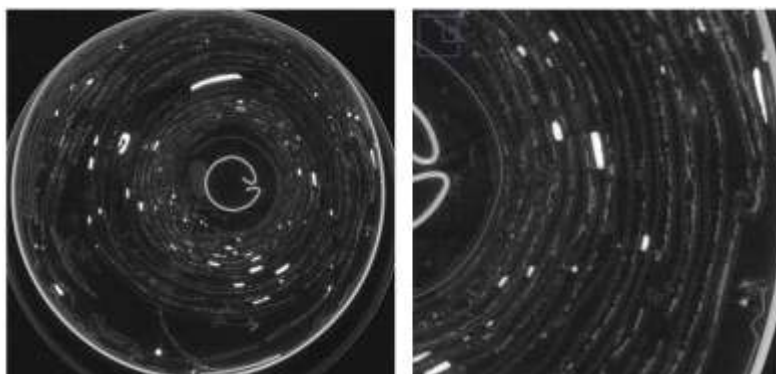
Fig. 70. Post-mortem tomograph showing the remnants of battery internals after overcharging at 7 A and heating above 150 °C. Post-mortem tomograph showing a focused region after overcharging at 7 A and heating above 150 °C.

No noticeable change in the internal structure of the battery was noticed during the overcharging process. It's possible that lithium plating occurred but the high X-ray transparency of lithium may have prevented the occurrence from being observed. A similar post-mortem image to the overheating of a fully charged NMC cell was seen. There is evidence of copper globules indicating that internal temperatures reached in excess of 1085 °C. It's worth noting that thermal runaway occurred at a lower temperature than the fully charged NMC battery.

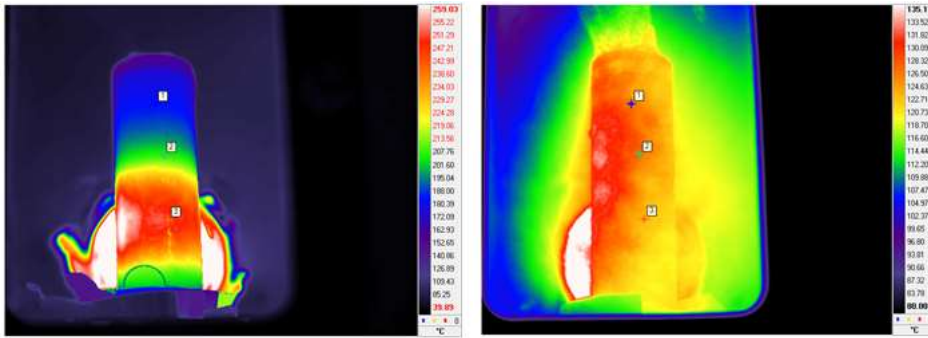
Fig. 71. Thermal image during the fast tomography thermal abuse experiments of $\text{Al}_{123} \text{FePO}_4$ batteries. Thermal image at point of explosion during the fast tomography thermal abuse experiments of $\text{Al}_{123} \text{FePO}_4$ batteries.

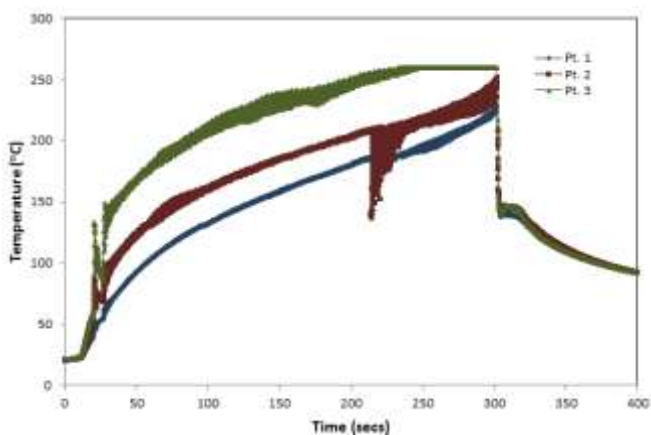
Fig. 72. Temperature plotted against time at points 1, 2 and 3 on the batteries surface. The drop in temperature at point 2 at around 200 s is due to electrolyte material flowing down the side of the battery after venting. After about 250 s the thermal cameras maximum temperature was reached; the maximum temperature reached by the battery was not captured.

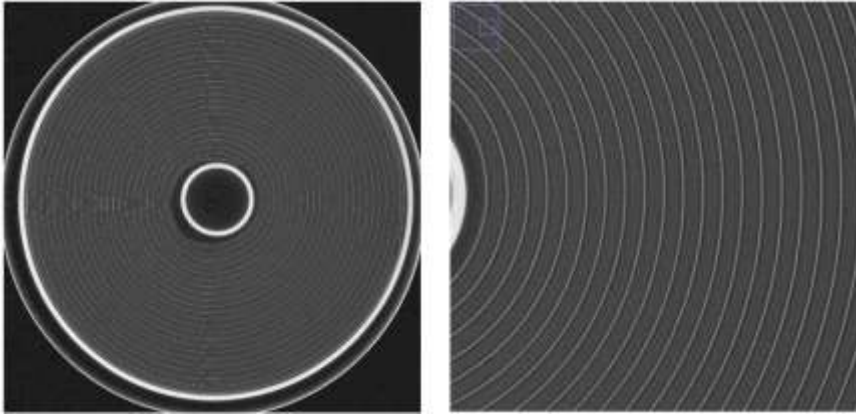
Fig. 73. Tomograph showing the initial state of the $A_{123} \text{FePO}_4$ battery before thermal abuse test. Tomograph focused on a region of the $A_{123} \text{FePO}_4$ battery for later comparison.

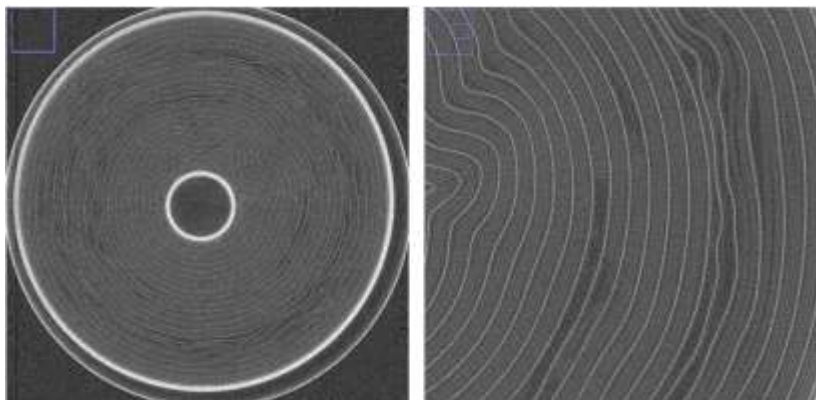
Fig. 77. Fast tomography tomograph showing the extent of degradation about 2 s before thermal runaway. Fast tomography tomograph showing the extent of degradation about 2 s before thermal runaway.

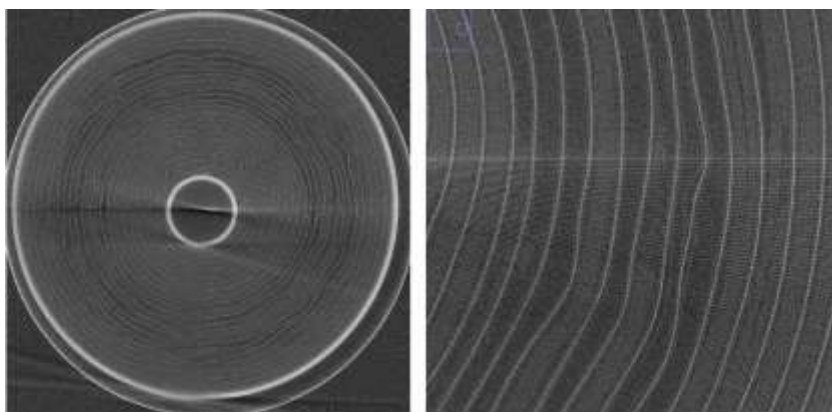
Fig. 78. Fast tomography tomograph capturing the state of the A123 FePO₄ battery at the point of initiation of thermal runaway. Image artefacts are caused by sample motion during the 0.4 second tomography scan. Fast tomography tomograph showing magnitude of degradation of the A123 FePO₄ battery at the point of initiation of thermal runaway. Image artefacts are caused by sample motion during the 0.4 second tomography scan.
