Report on HS2252

In this group of experiments we have performed a number of grain tracking and in-situ stress corrosion cracking measurements.

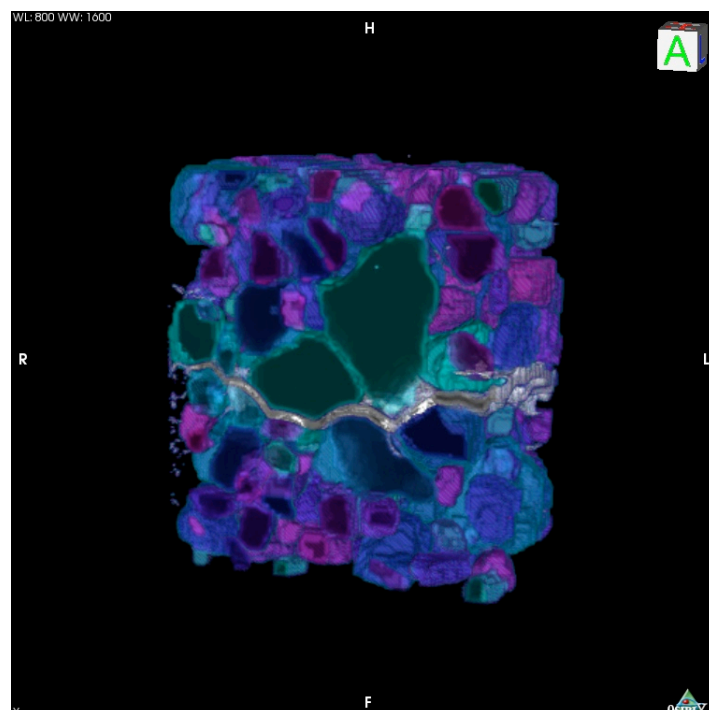
We have been able to successfully analyse these datasets to determine the shapes and orientations of grains in a stainless steel wire, and hence produce the first non-destructive, in-situ 3D visualisation of a crack interacting with a polycrystalline microstructure. This is a very significant achievement in this field of materials science. In the figure, the crack (white) can be seen follow the boundaries of grains (coloured).

Following the acquisition of tracking datasets, samples have been transferred to beamline ID19 for in-situ observations of stress corrosion cracking. Tomographic datasets have been acquired for a number of increments of crack growth, from initiation to failure. The crack dataset has been combined with the grains found by DCT, and excellent agreement can be seen between the two. Analysis, now in progress, will determine grain boundary characteristics (misorientation between grains, boundary crystallographic planes, identifying special boundaries), and reveal which have failed easily, and which remain bridging the crack in its final stages.

For the grain tracking measurements we have adopted the diffraction contrast tomography technique, pioneered at beamline 19 as part of a collaboration with the Risø group. In the most recent beamtime allocation the equipment necessary for this technique was installed at beamline ID11 to benefit from the increase flux available compared to ID19. The software necessary to analyse such datasets has been developed as part of this project. In the dataset shown, approximately 350 grains have been reconstructed.
